Slope Stability of Darbendikhan Dam Site and Near Surroundings. A Reconnaissance Study, Kurdistan Region, NE Iraq

Varoujan K. Sissakian¹, Sakar A. Sdiq² and Govar K. Haris³

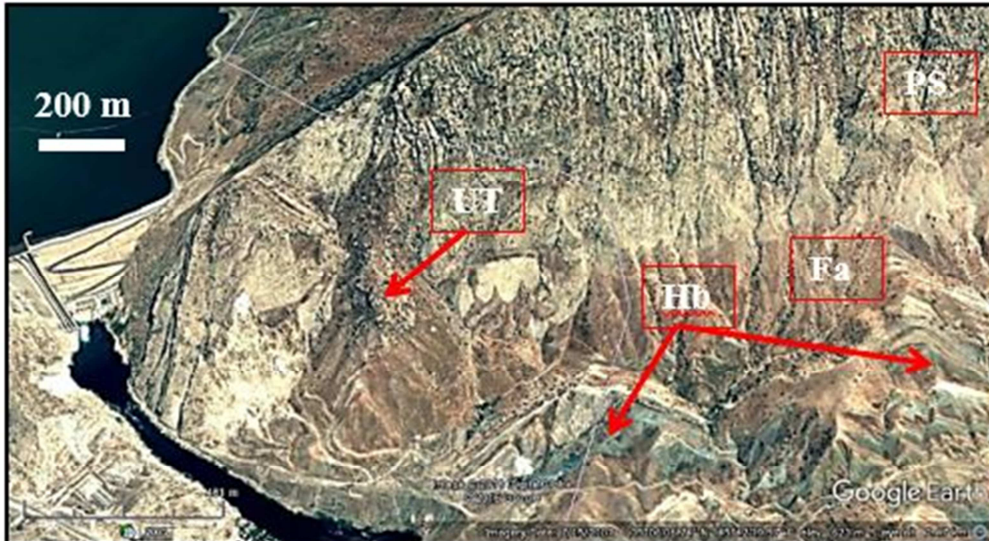
Figure 2: Google Earth image facing NW shows anticlinal ridges in Pila Spi (PS) and Fatha (Fa) formations. Note the unstable terraces (UT) on top of an anticlinal ridge and also note Hogbags (Hb).

- **Fluvial Unit:** Among them are **Terraces**, which are developed in many stages. Higher old stage forms unstable slope downstream side (Fig. 2).
- **Denudational Unit:** Among this unit is the original slopes (Fig. 3). These are the main form that has formed the most unstable parts in the studied area.
- **Mass Movements:** Among them are **Mud Flow, Landslide, Rock Fall and Creep** (Fig. 3). These phenomena are developed in soils and rocks in different sizes. Some of them are very active; others are dormant.

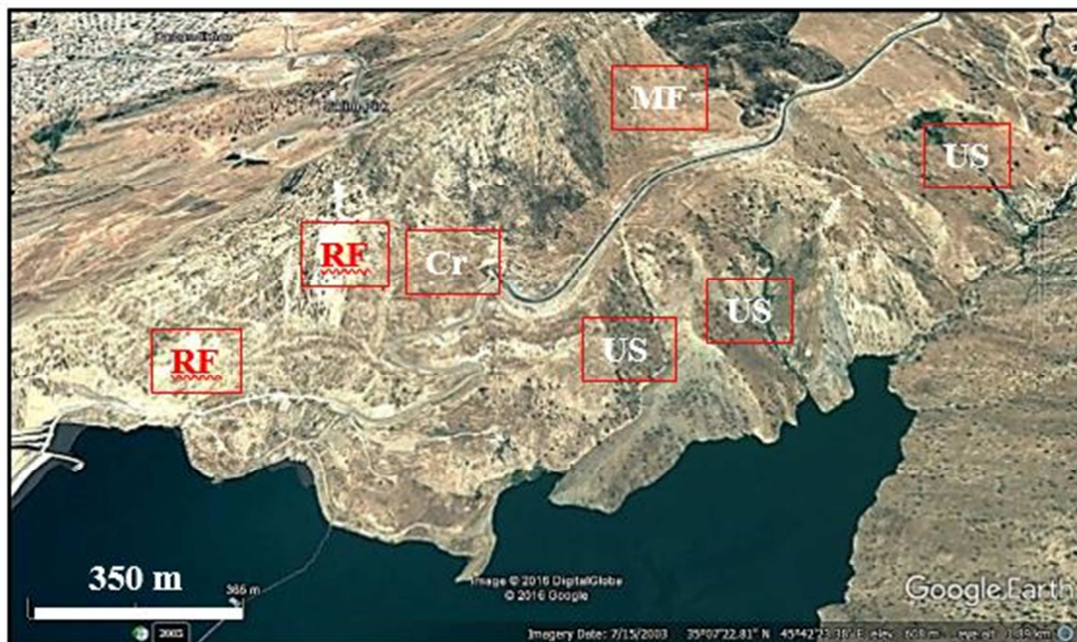
Figure 3: Google Earth image showing erosional slopes. Note the majority of the slopes are unstable (US), also note rock fall (RF), Mud Flow (MF), Landslide (LS) and Creep (Cr) phenomena.

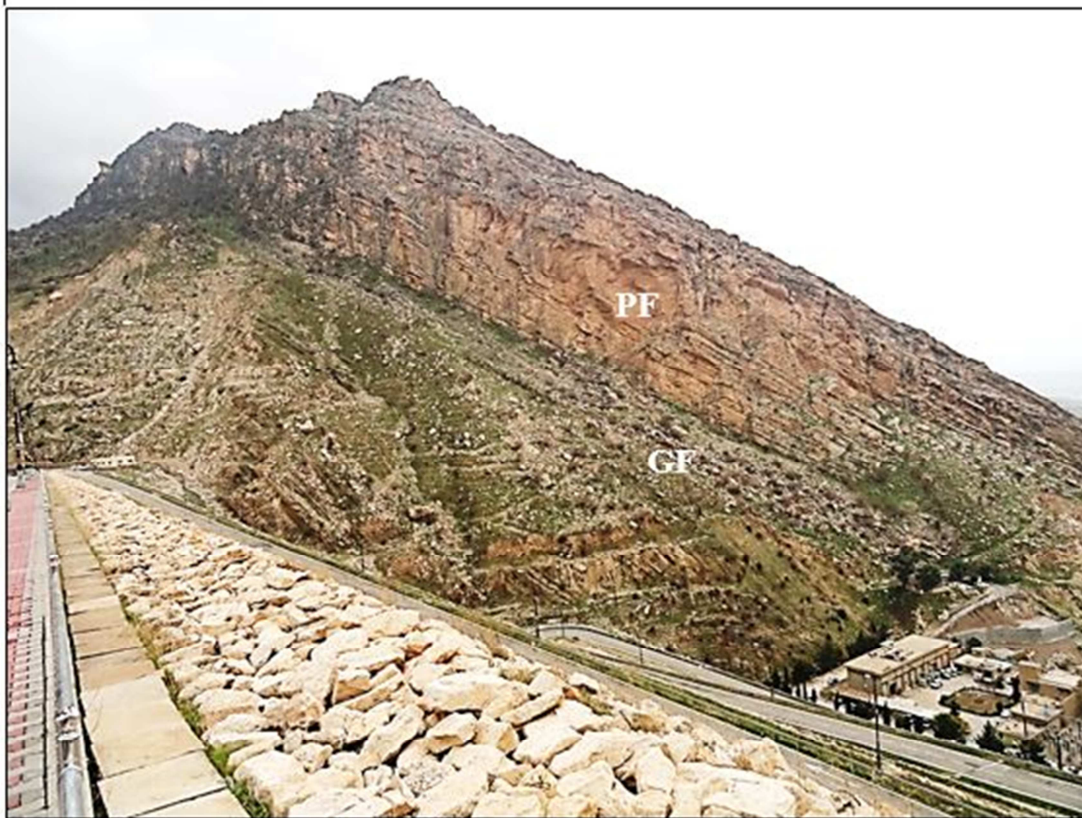
Figure 5: The crest of the Darbendikhan Dam, in the back ground is the Gercus Formation (**GF**) overlain by the Pila Spi Formation (**PF**). Note the fallen rock blocks from the Pila Spi Formation and the unstable slopes within the Gercus Formation.

The dam is located within a gorge on a foundation of the rocks of the Gercus Formation; it is overlain by the Pila Spi Formation (Figs. 1 and 5) (Sissakian and Fouad, 2014) [9].

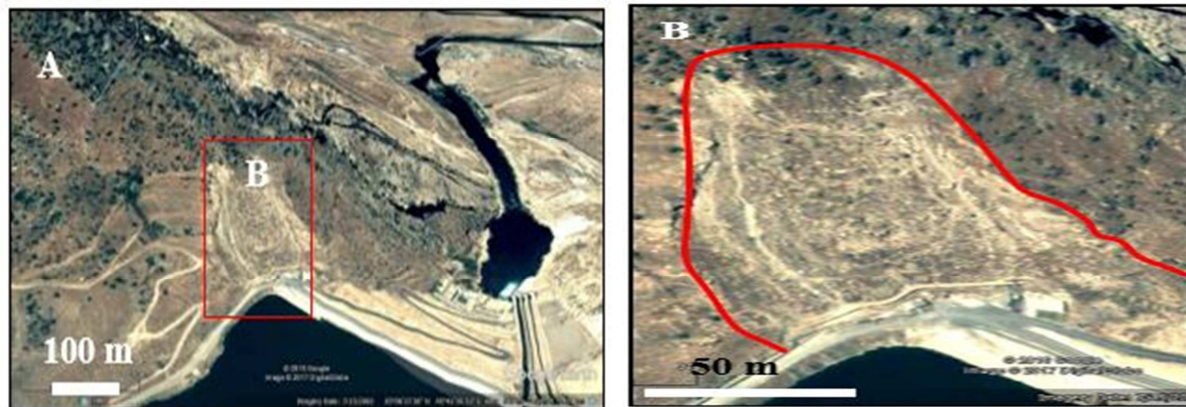
- **Station 1:** The station is within Kolosh and Gercus formations. The main mass movements' phenomena are landslide, creep and toppling. The main landslides and creep phenomena are presented in Figure (6). The applied LPI estimation for this station is presented Table (1).

Figure 6: A) Google Earth image shows unstable slopes along the left bank of upstream slopes (**Station 1**). B) Details of the main landslide. The red line represents the main unstable slope

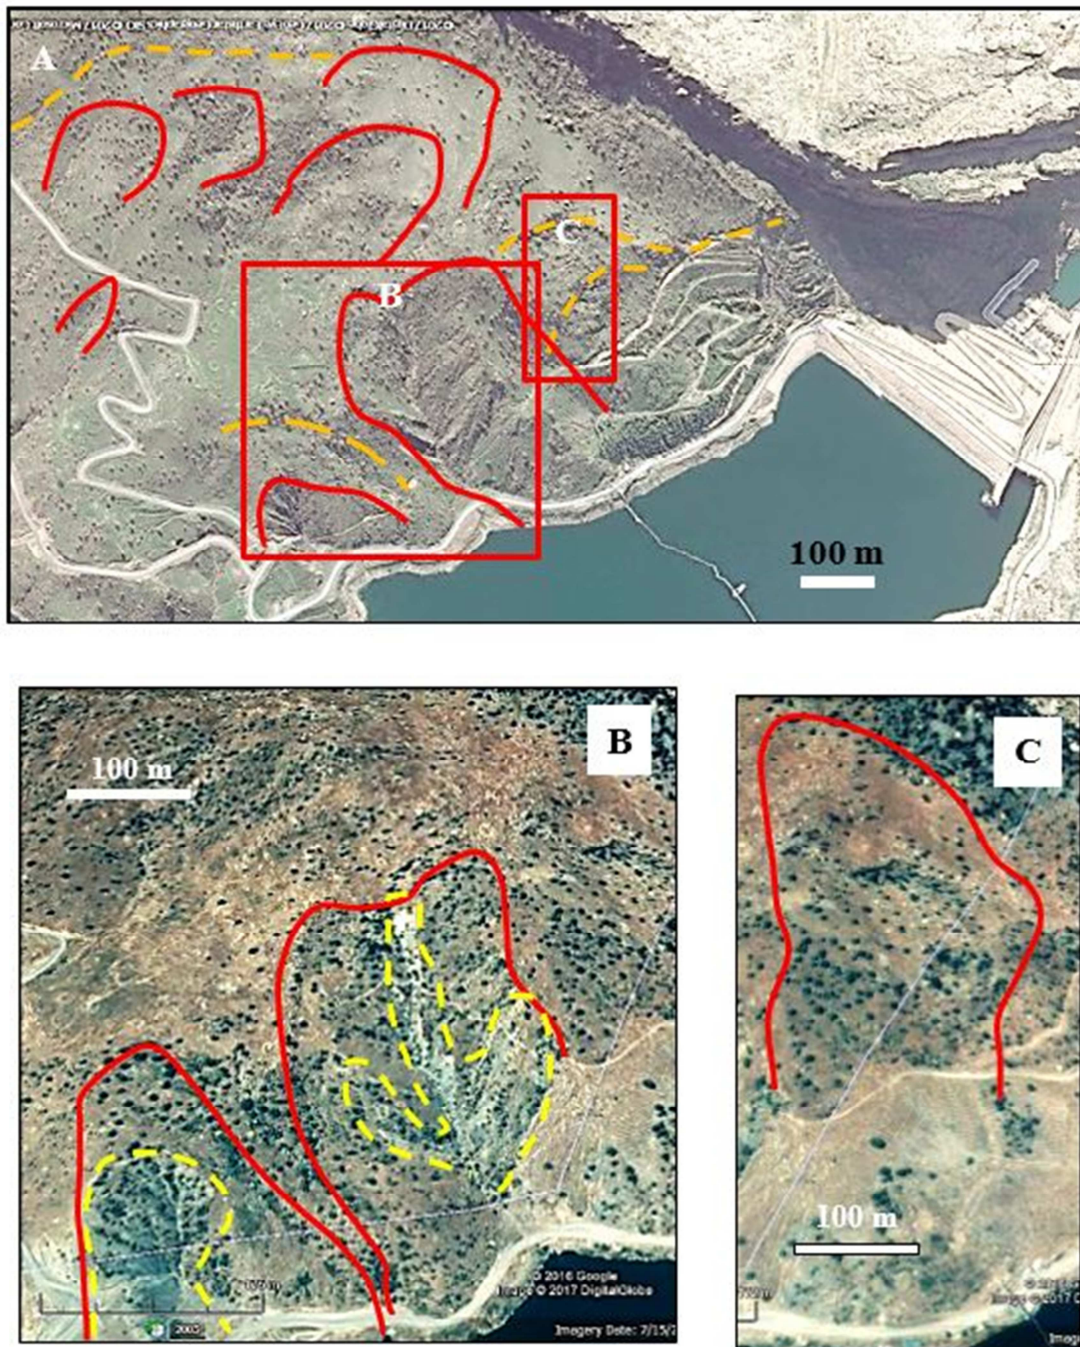
- **Station 2:** The station is within Kolosh and Gercus formations. The main mass movements' phenomena are landslide, creep and toppling. The main landslides and creep phenomena are presented in Figure (7). The applied LPI estimation for this station is presented Table (1).

Figure 7: **A)** Google Earth image showing unstable slopes along the left bank of the upstream slopes (**Station 2**). **B)** Two old landslides with active areas and **C)** Old landslide. The red lines represent the main landslides. The dashed orange lines represent the main creep area and the yellow dashed lines represent active erosion areas.

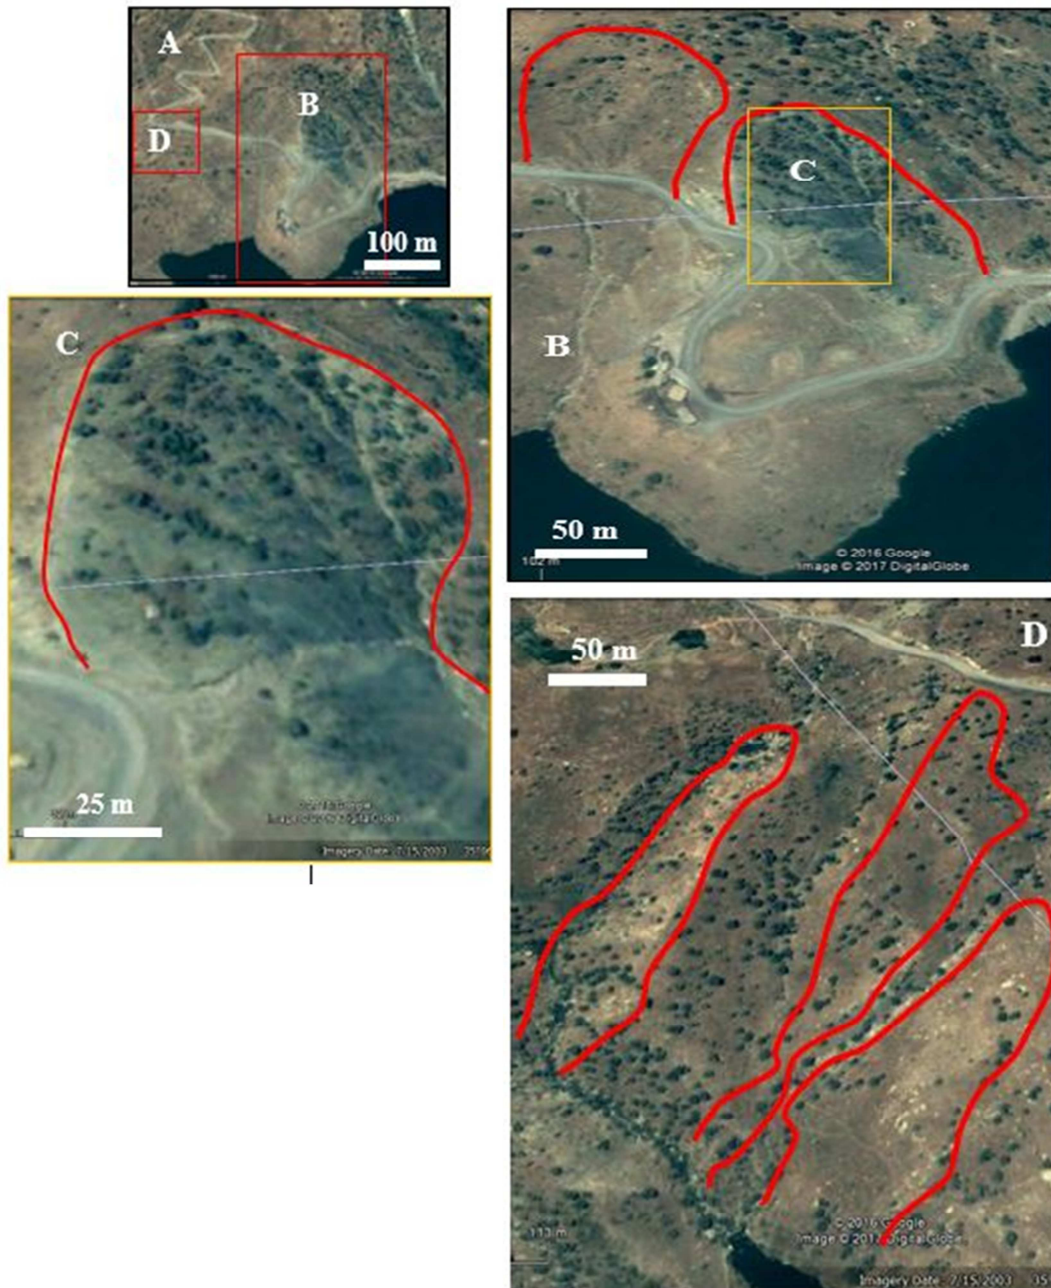
- **Station 3:** The station is within Kolosh and Gercus formations. The main mass movements' phenomena are landslide and creep. The main landslides and creep phenomena are presented in Figure (8). The applied LPI estimation for this station is presented in Table (1). Moreover, many areas suffer from active
- erosion, which will trigger different types of mass movements in the near future; if no relevant precautions are considered.

Figure 8: Google Earth image of the left bank of upstream slopes (**Station 3**). **A**) Old landslide, **B**) Details of part of the old landslide **C**) Active slide area, **D**) Three old landslides. Red lines are the limits of the landslides.

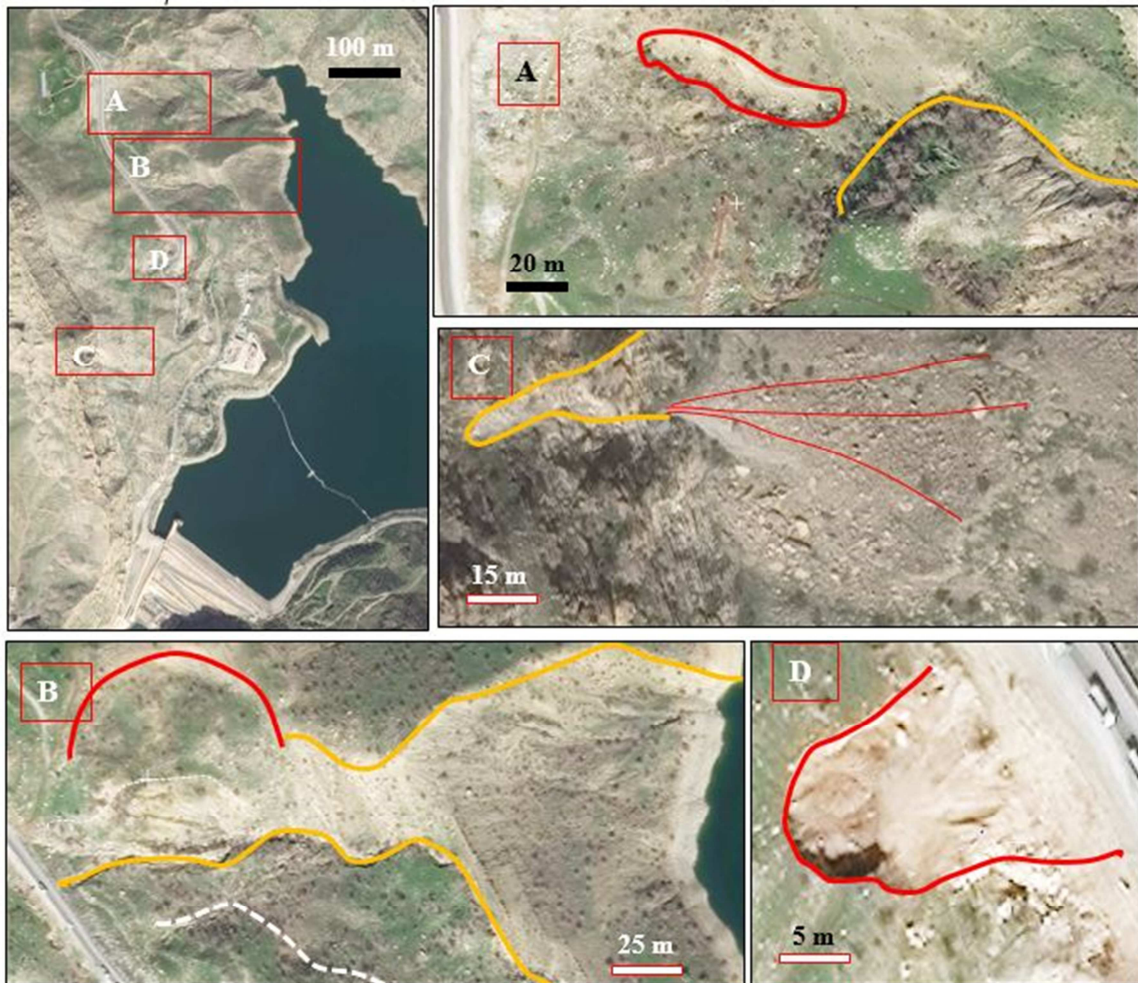
- **Stations 4, 5 and 6:** These stations are within Kolosh and Gercus formations on the right side of upstream slopes. The main mass movements' phenomena are landslide, creep and rock fall. The main landslides and creep phenomena are presented in Figure (9). The applied LPI estimation for these stations is presented in Table (1). Moreover, many areas suffer from active erosion, which will trigger different types of mass movements in the near future; if no relevant precautions are considered.

Figure 9: Flash Earth image of the right bank of upstream slopes (**Stations 4, 5 and 6**). **A**) Old landslide with active erosion area (**Station 4**), **B**) Active erosion along valley bank with creep phenomenon (**Station 5**), **C**) Rock fall (**Station 6**); forming active rock fan, **D**) Small active landslide. The red lines represent the main landslides. The dotted white lines represent the main creep areas. The orange lines represent the limits of active erosion areas.

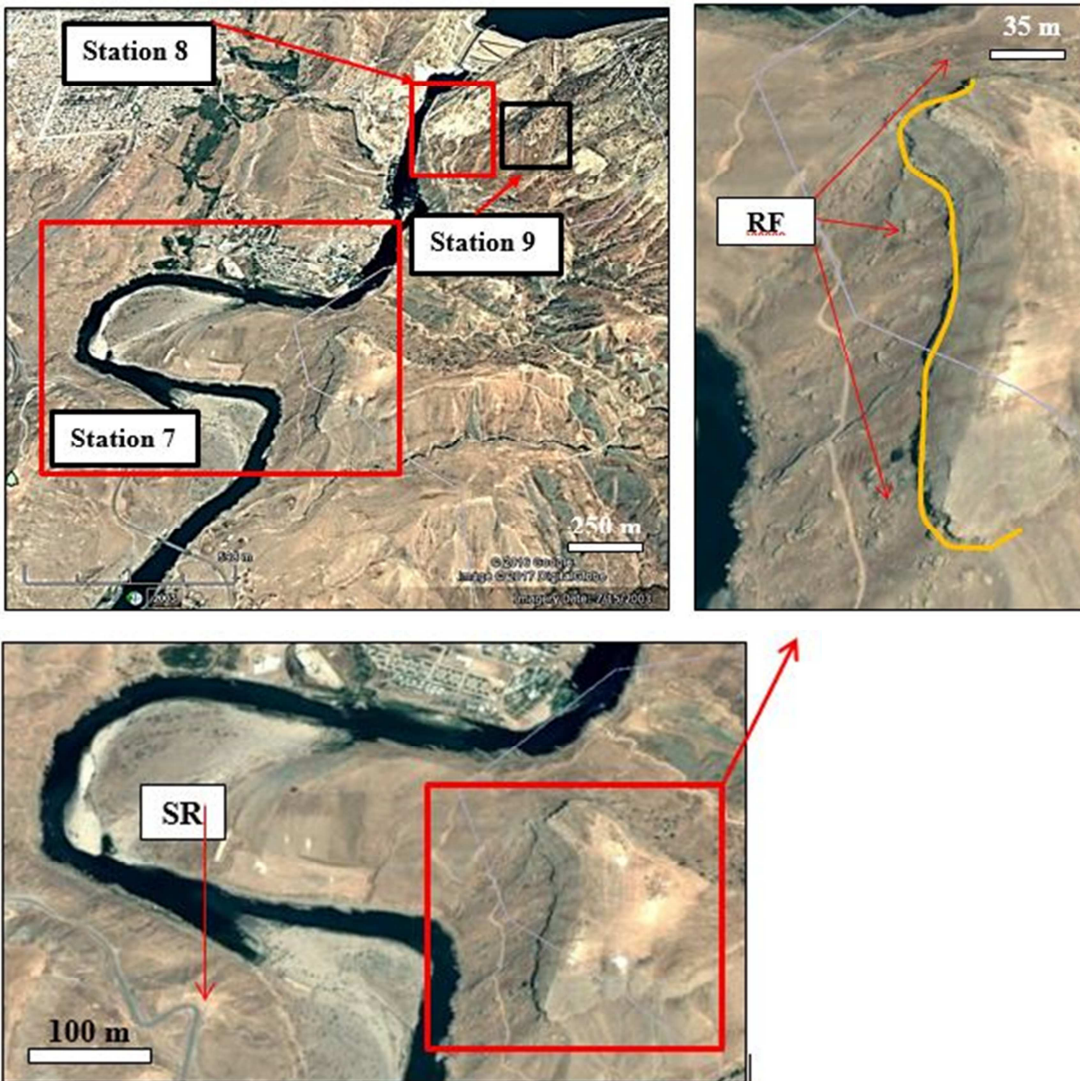
- **Station 7:** This station is within the Fatha Formation. The main mass movement phenomenon is a very old landslide (Fig. 10, **A**). The applied LPI estimation for this station is presented in Table (1). The steep slope is a prone area for rock fall of large blocks endangering the unpaved road.

Figure 10: Google Earth image of the left bank of downstream slopes (**Station 7**). **Top**) Very old landslide that has shifted the river course, **Bottom**) Details of the old slide, note the steep slope, fallen rock blocks (**RF**), slid part of the road (**SR**) and active erosion areas. In orange is the scarp of the active rock fall area. Compare the size of the fallen blocks with the width of the road.

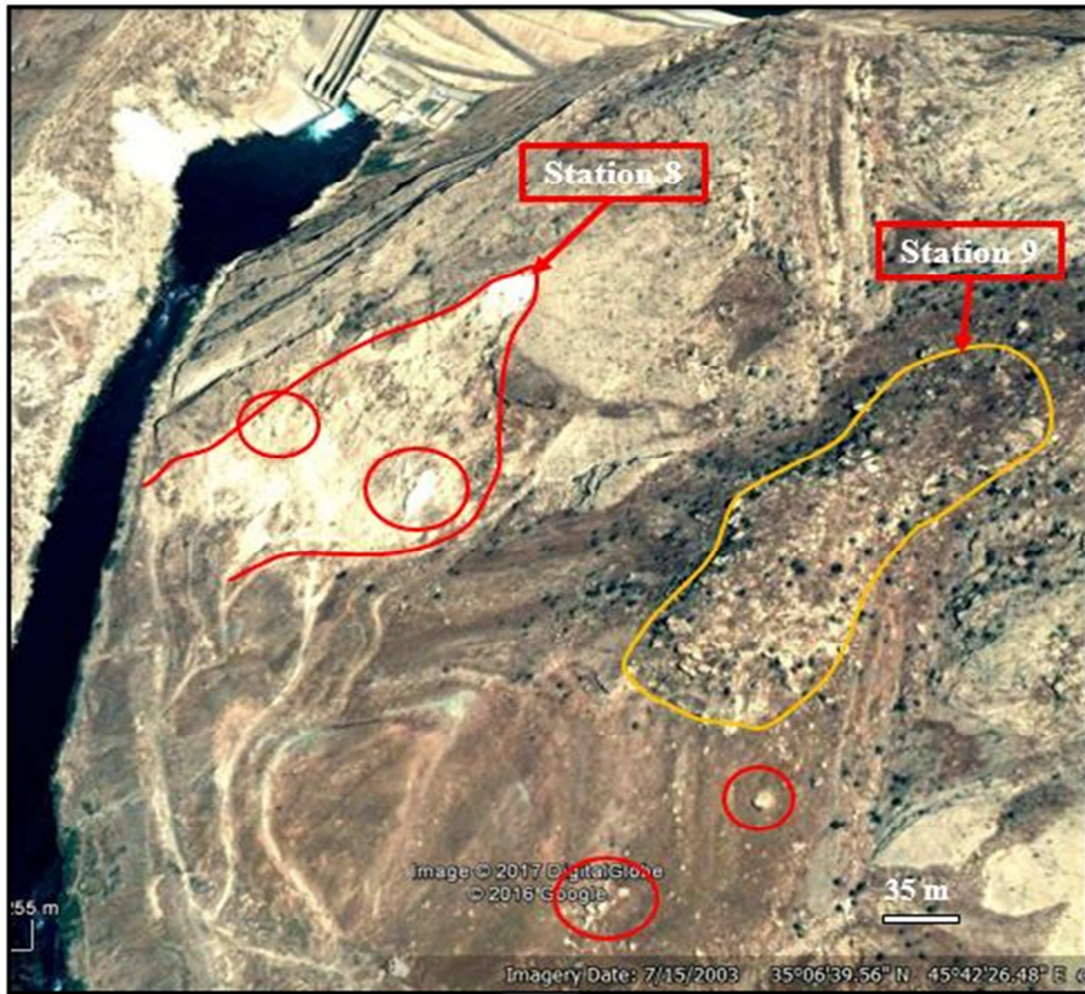
- **Station 8:** This station is within the Pila Spi (Fig. 11). It is an active rock fall with a very steep slope. The applied LPI estimation for this station is presented in Table (1). The steep slope is a prone area for rock fall of large blocks endangering the unpaved road.
- **Station 9:** This station is within the terraces of the Serwan River (Fig. 11). It is an active rock fall area for parts of the old preserved terrace body and the pebbles; with a very steep slope. The applied LPI estimation for this station is presented in Table (1).

Figure 11: Google Earth image of **Stations 8 and 9**. Note the very active rock fall area (Station 8) with large blocks being in very critical equilibrium. Also, note the old river terrace body (Station 9) and the fallen large blocks. (Some of the blocks are encircled by red).

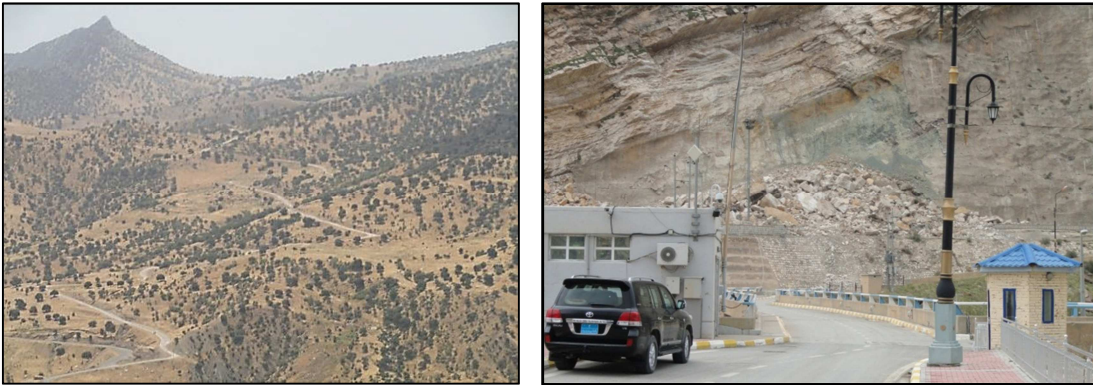
The upstream side of Darbendikhan Dam forms a tectonically controlled depression; formed in the core of Darbendikhan anticline. This is attributed to the presence of hard carbonate rocks of the Pila Spi Formation; along both limbs of the anticline; whereas, the soft clastics of the Gercus and Kolosh formations form the core (Figs. 1 and 4). Therefore, majority of the slopes on both sides of the upstream are unstable exhibiting different mass movements' phenomena. Among the movements are landslides, creep, flow and very rare rock fall. However, many of them are very old and dormant; others are still active (Figs. 3, 5, 6, 7, 8 and 9). The unstable slopes nature is attributed to the following: **1)** Steep slopes including soft clastic rocks, which are easily eroded by rain water; besides being highly pervious; consequently, oversaturated. This in term will cause decrease in the internal friction angle (Terzaghi, 1943 and Terzaghi et al., 1996) [12 and 13], **2)** Construction of roads along the slopes with haphazard cuts (Fig. 12, Left) has affected on the stability of the slopes due to road cuts, which are left without any treatment; consequently has developed very active erosional areas and/ or facilitating rain water infiltration, **3)** The well bedded carbonate rocks of the Pila Spi Formation are underlain by soft clastic rocks of the Gercus Formation, the difference in the hardness has developed day light slopes, which exhibit continuously rock falls; although in a small scale (Fig. 12, Right).

Figure 12: Upstream slopes of the Darbendikhan Dam. **Left)** Constructed unpaved roads with haphazard road cuts, **Right)** A rock fall in the day light slopes of the Pila Spi Formation.
