## Landslide susceptibility assessment along Biyara-Tawella road, Kurdistan region, NE-Iraq

Fahmy Osman Mohammed<sup>1\*</sup>, Ashna Jalal Ahmed<sup>1</sup> and Sarkhel Hawre Mohammed<sup>1</sup>

*1 Department of Geology, College of Science, University of Sulaimani, Sulaimani, Kurdistan Region- Iraq*

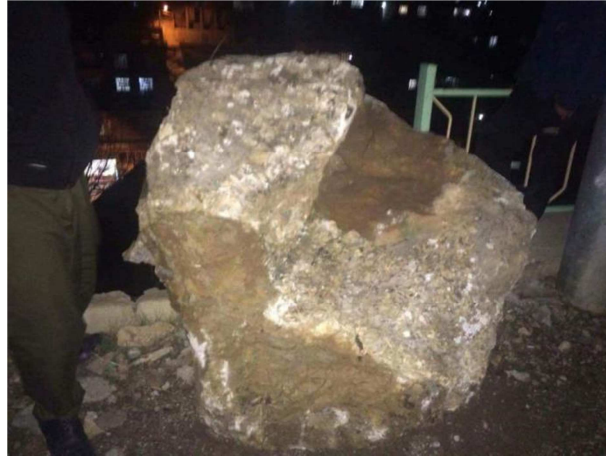
The main types of landslide in the studied area is rockfall because the area located at the boundary between Arabian plate and Eurasian Plate which characterized by high tectonic activity and seismic activity lead to imbrication and intense deformation in the country rock, the other causal factors for the cut slope are intense rainfall during rainy season, high erosive shale layer between highly fractured rocks of radiolarian chert and recent high magnitude earth quack activity is a good example (Figure 6).

Figure 6: Large rock block was collapsed due to the effect of an Earthquake inside Tawela Town

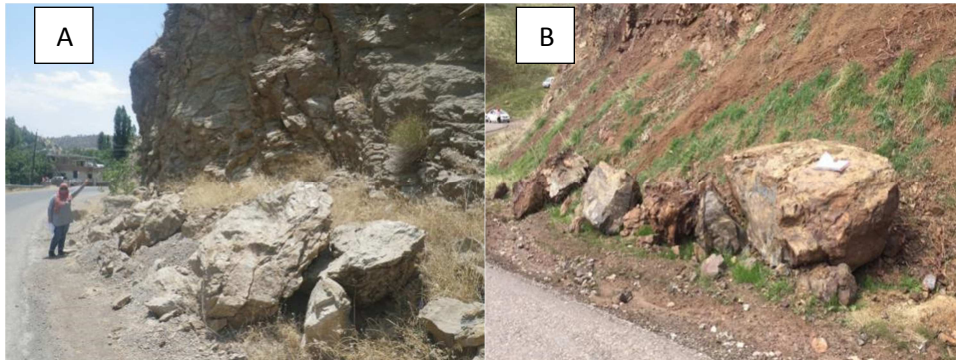
In the studied area along the road 24 site were surveyed, 95% of the studied slopes were shown High hazard categories (Figure 7a,7b)and only site (No.4) (Figure 8) show moderate hazard categories (Table 1). The rockfall is the main type of slope failure and it can be seen in all surveyed slopes, lateral detachment, except in one site wedge sliding was recorded.

Figure 7: a, shows a large block fall at site No. 24 b, shows a large block fall at site No. 19

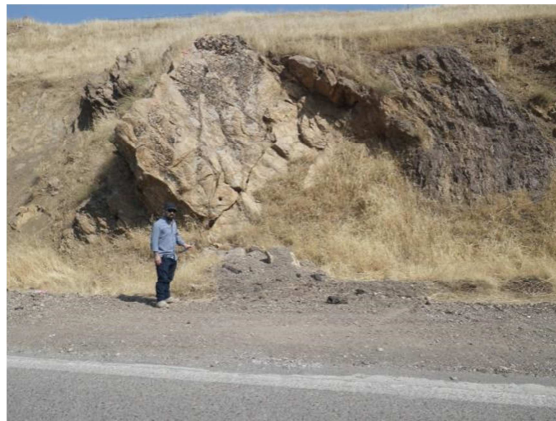
Figure 8: front view of site No.4 shows moderate (LPI) hazard category

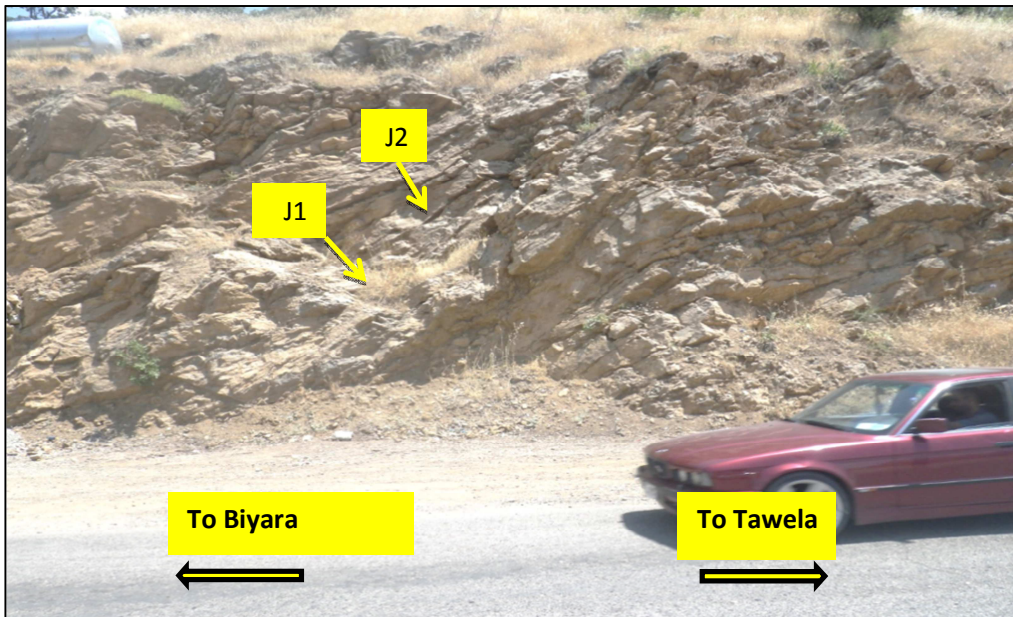
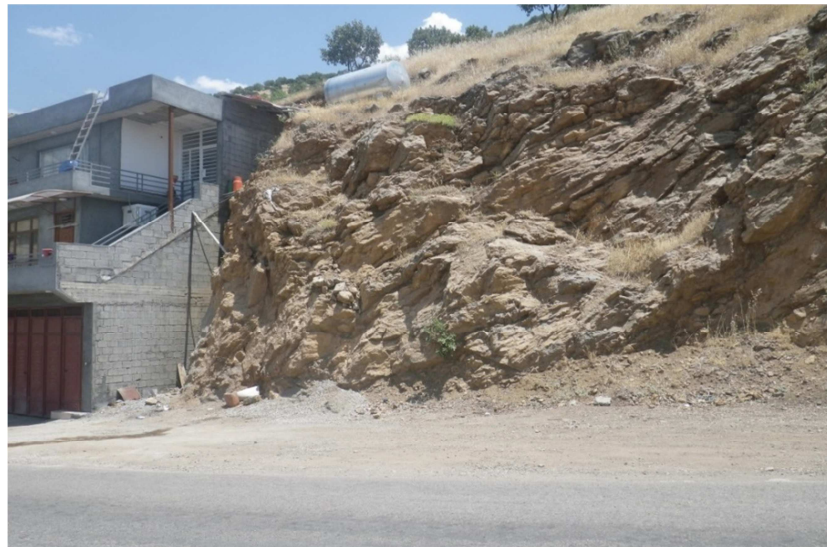
The kinematic analysis for Site (No.22) shows wedge sliding type of slope failure with the possibility of 66.67% (Figure 9a,9b,10), due to the intersection of two sets of joints (J1:286/64, J2:53/207), the line of the intersection was located within the direction of slope (SW).

Figure 9a: front view of the site No.22 showing wedge sliding

Figure 9b: lateral view of the site No.22 showing wedge sliding

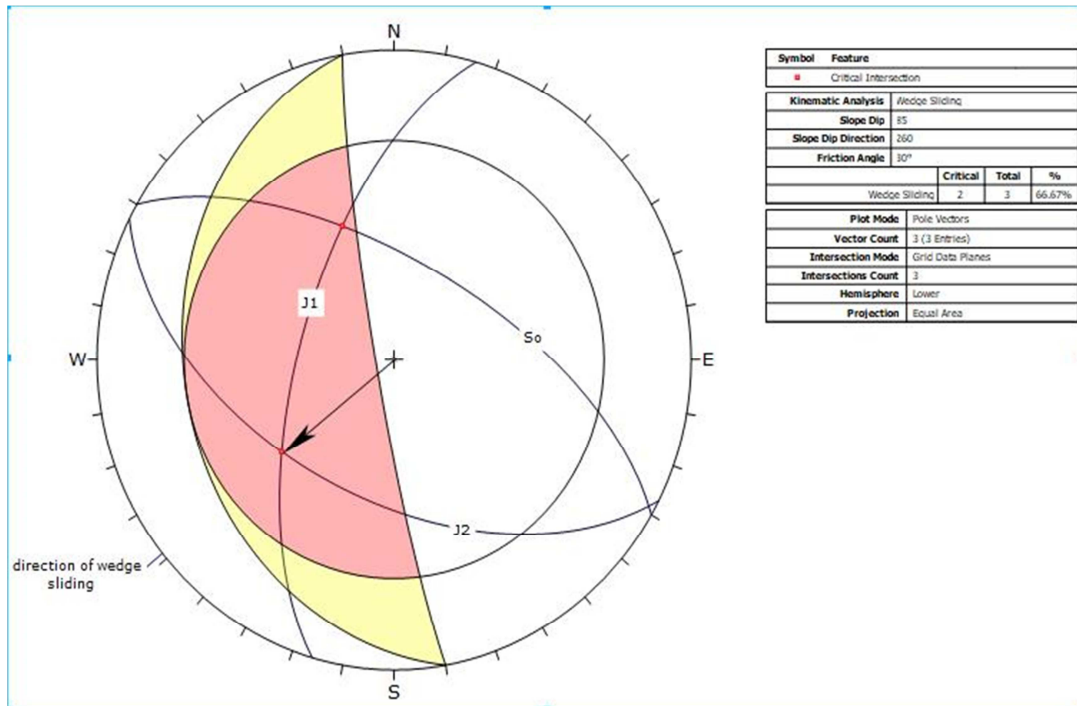
Figure 10: Kinematic analysis result for site No.22 showing wedge sliding and critical intersections (red circles).

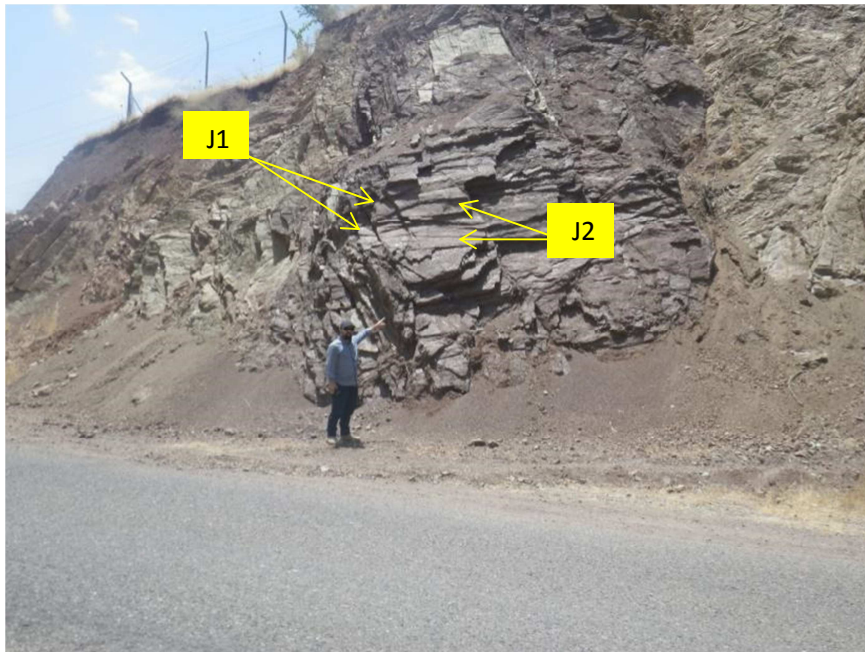
The Site (No.23) reveal lateral detachment type with the possibility of 33.32% (Figure 11,12) which formed due to the intersection bedding with a joint set (J1: 90/120), and the line of intersection (So, J1) located in the direction of slope (N30E)

Figure11: site No.23 showing the detached blocks due to differential erosion

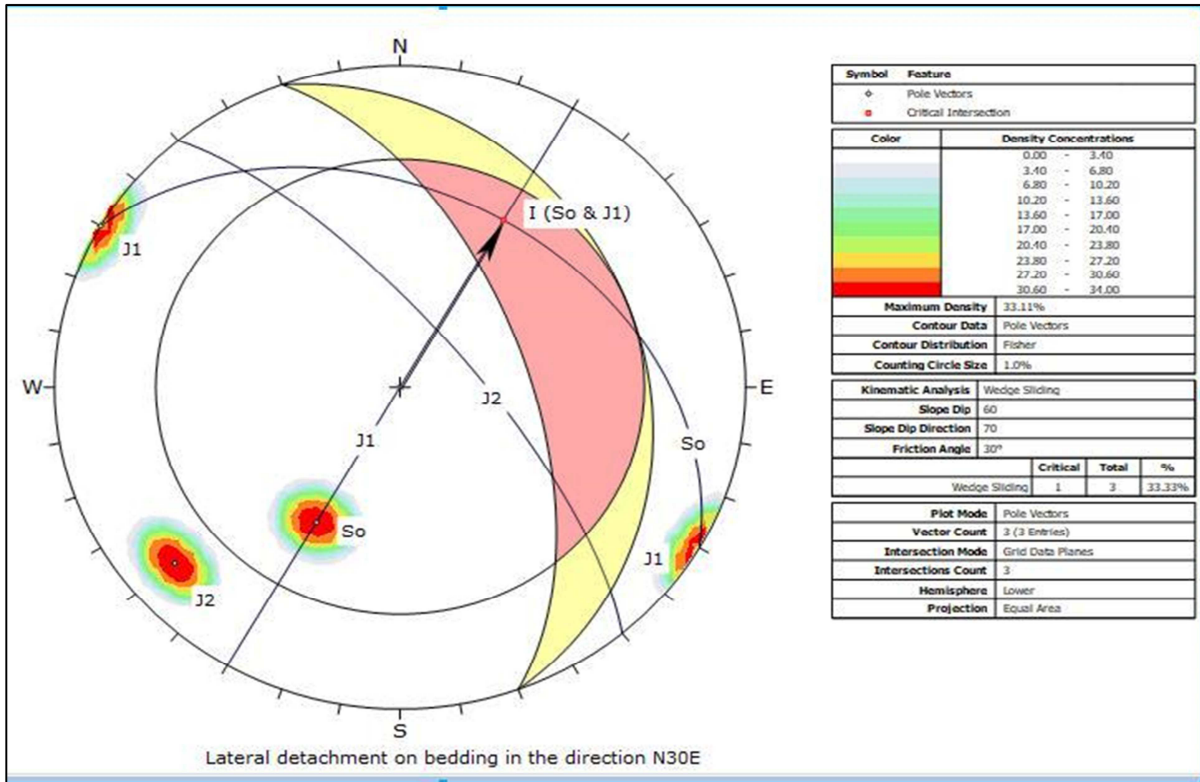
Figure 12: Kinematic analysis site 23 Stereonet plot of joint orientation and Failure envelope for Lateral detachments on bedding (So, J1).

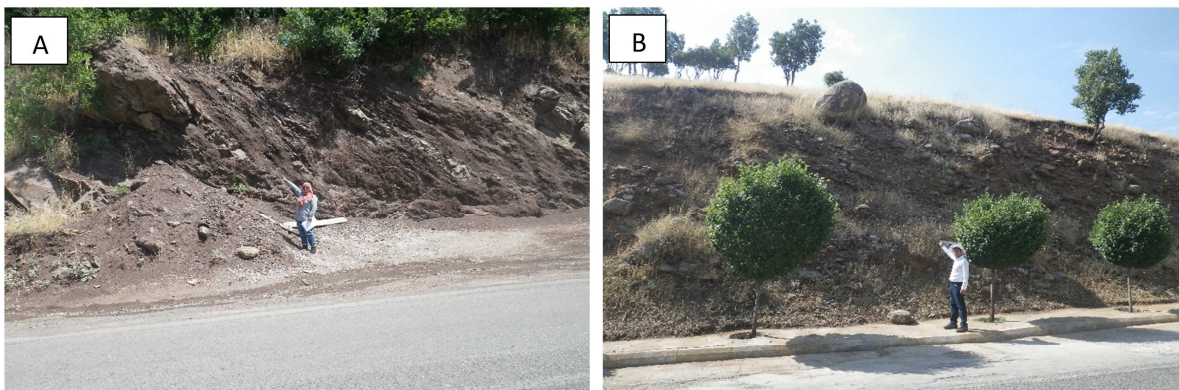
The RHRS analysis was applied on the rock mass of 12km long road which composed of bedded chert, shale and siliceous limestone of Qulaqula Formation includes many fault shear zones and it is classified as a crushed zone due to intense deformation (Figure 13a). The unstable slopes were created by either removing the underlying supports (slope toe) (Figure 13b), and differential erosion of the shale or road cutting.

Figure 13: a, shows the crushed rock mass at site No.15 b, quaternary deposit at site No.2
