QARA-CHATTAN ROCKSLIDE IN PIRA-MAGROON ATICLINE, NORTHEASTERN IRAQ

By: Kamal Haji Karim Ahmad *
Ghafor Ameen Hamasur *
Sherzad Tofiq Mohamad *

This paper deals with a rock failure from Pira-Magroon Mountain, Northeastern Iraq. Field study and graphical representation showed that this failure is a rockslide. Being located near Qara-Chattan village, we named this phenomenon as Qara-Chattan Rockslide. About 200 million tons of rock materials are slid from the elevation of 2900 meters above sea level to the elevation of 1000 meters. The slide rock debris now rested on a gently sloping plain near the village and forming a tongue like hill about 50 meters high. Many geomorphologic features and slide activating factors are also discussed as well as stereonet analysis of the rockslide.

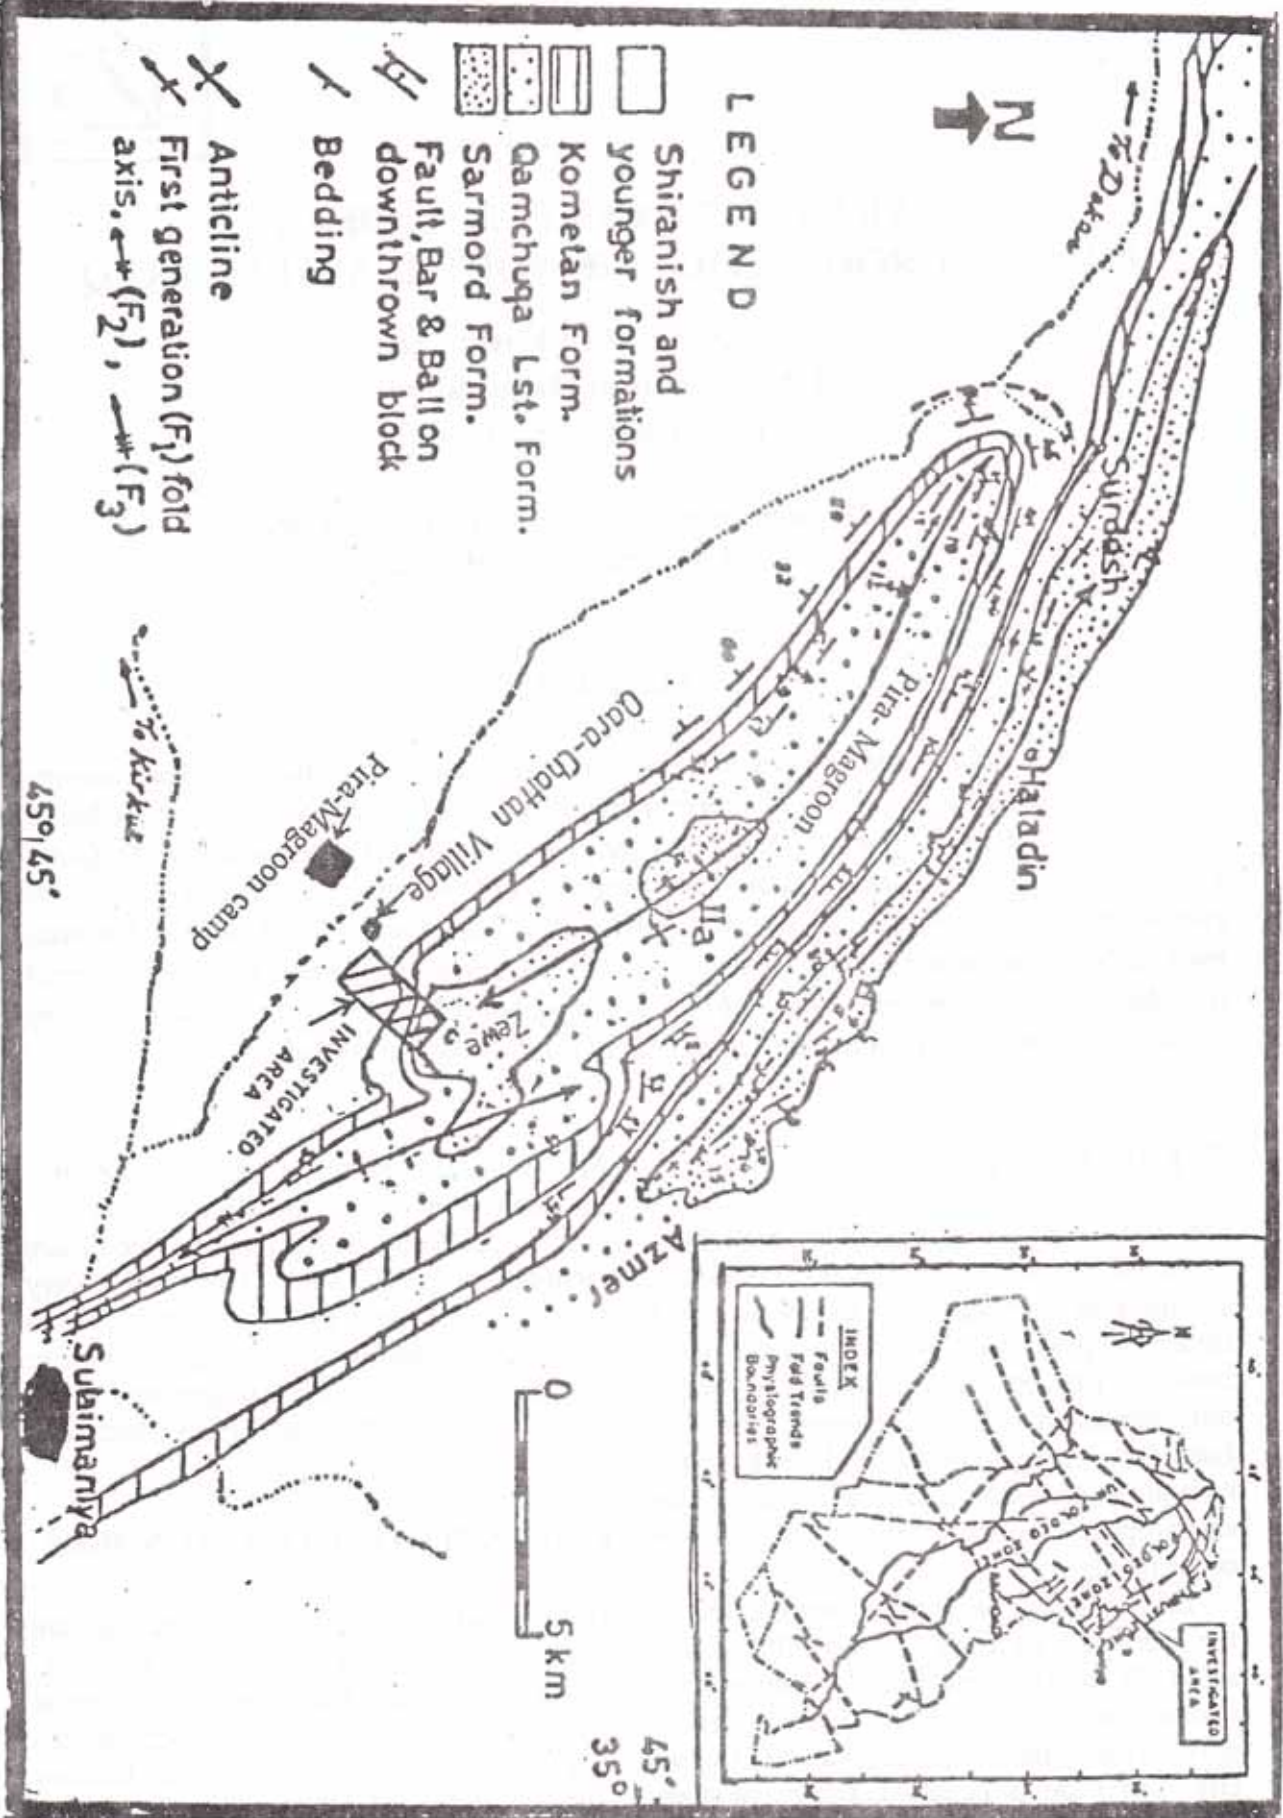
Fig(1) Geological map of Pira Magroon anticline (Al-Fadhli et al, 1979) (2).

Mountain. Structurally, it represents a double plunging asymmetrical anticline, fig. (1).

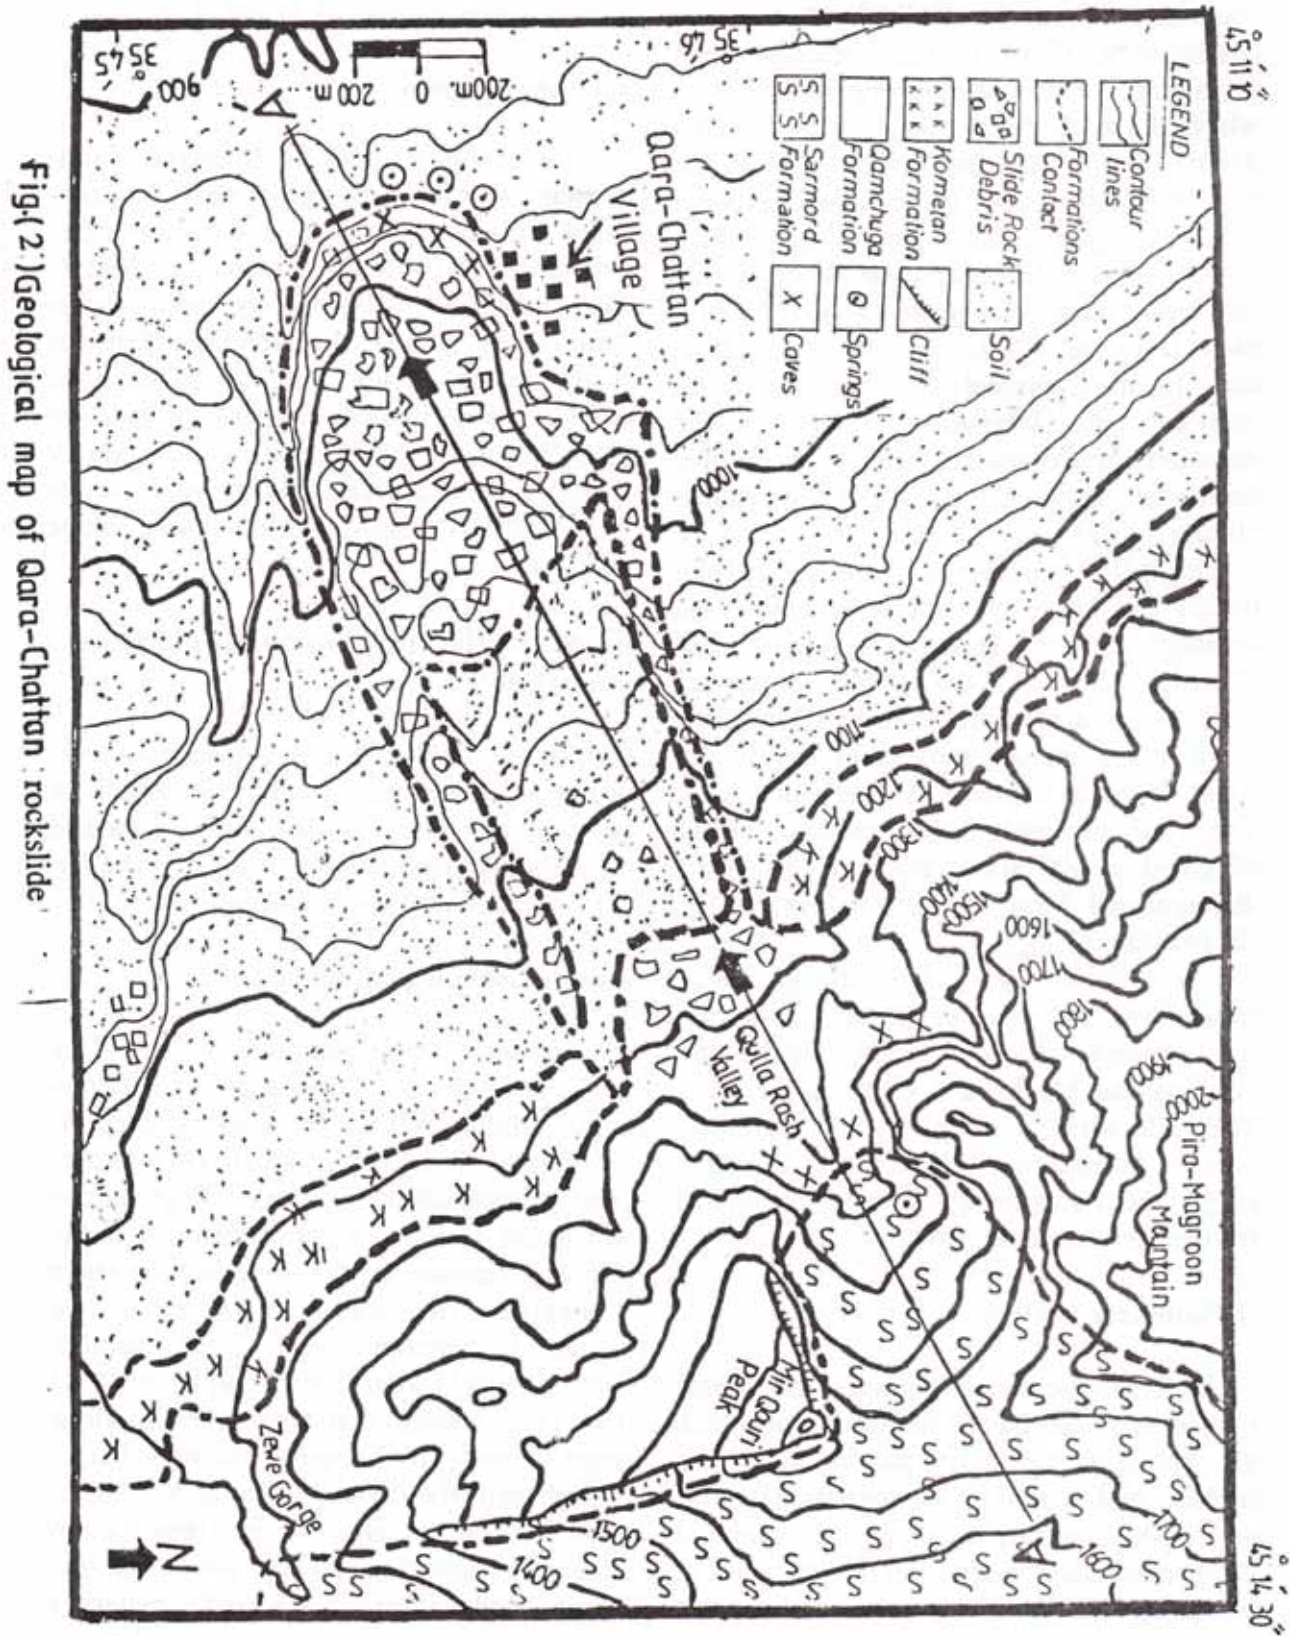
Fig.(2.) Geological map of Qara-Chattan rockslide

It is composed of recrystallized gray to brown dolomitic limestone, which belongs to Qamchuqa Formation (Middle Cretaceous) (Bellen et. al, 1959) (1). This Formation form a carapace of Pira-Magroon mountain from which the rock debris detached and moved down slope from the upper part of the mountain slope, near its crest and rested on gently sloping plain, near Qara-Chattan village. There the slided rocks debris form a relatively large elongated tongue-like hill, plate (1.1) and (2.1). It is about 50m high and its mass estimated to be about (200) million tons (Hamasur, 1999)(3). The direction of elongation is along the slope, from the slope toe toward Qara-Chattan village fig. (2).

The hill is composed of massive angular blocks and clasts of various sizes showing breakage and some brecciation. According to (Dennis, 1987)(4) the sliding slabs are transported rapidly and usually disintegrate down slope during movement and finally come to rest as jumbled and brecciated mass. The hill material, being contain blocks weighted about sixty tons, can be easily distinguished from the surrounding soil, fig. (2) and plate (1.2).

contour line, fig. (2) and plate (1.3). This represents former intersection line of the groundwater level with the slope surface. These caves are oval in shape and bounded by smooth internal surface, with many circular holes, which represent spring mouths. The groundwater is caused enlargement of the caves and followed by the failure of the slope. Moreover the cave floor covered by a layer of brown to earthy coarse calcite about 10cm thick. (This represents travertine deposit during seepage of groundwater plate (4.1). Railsback,et al., 1994)(8) are found calcite and partially dissolved aragonite layers in the caves of Late Holocene from Botswana .They returned aragonite layers to deposition in arid and high Mg/Ca environment The final effects of these caves are removal of slope supports (batters).

groundwater to flow in the direction of solution caves. The age relation between the fault and the rock slide is that the former one is older than the later which now form cliff at the back side of the valley, fig. (2).

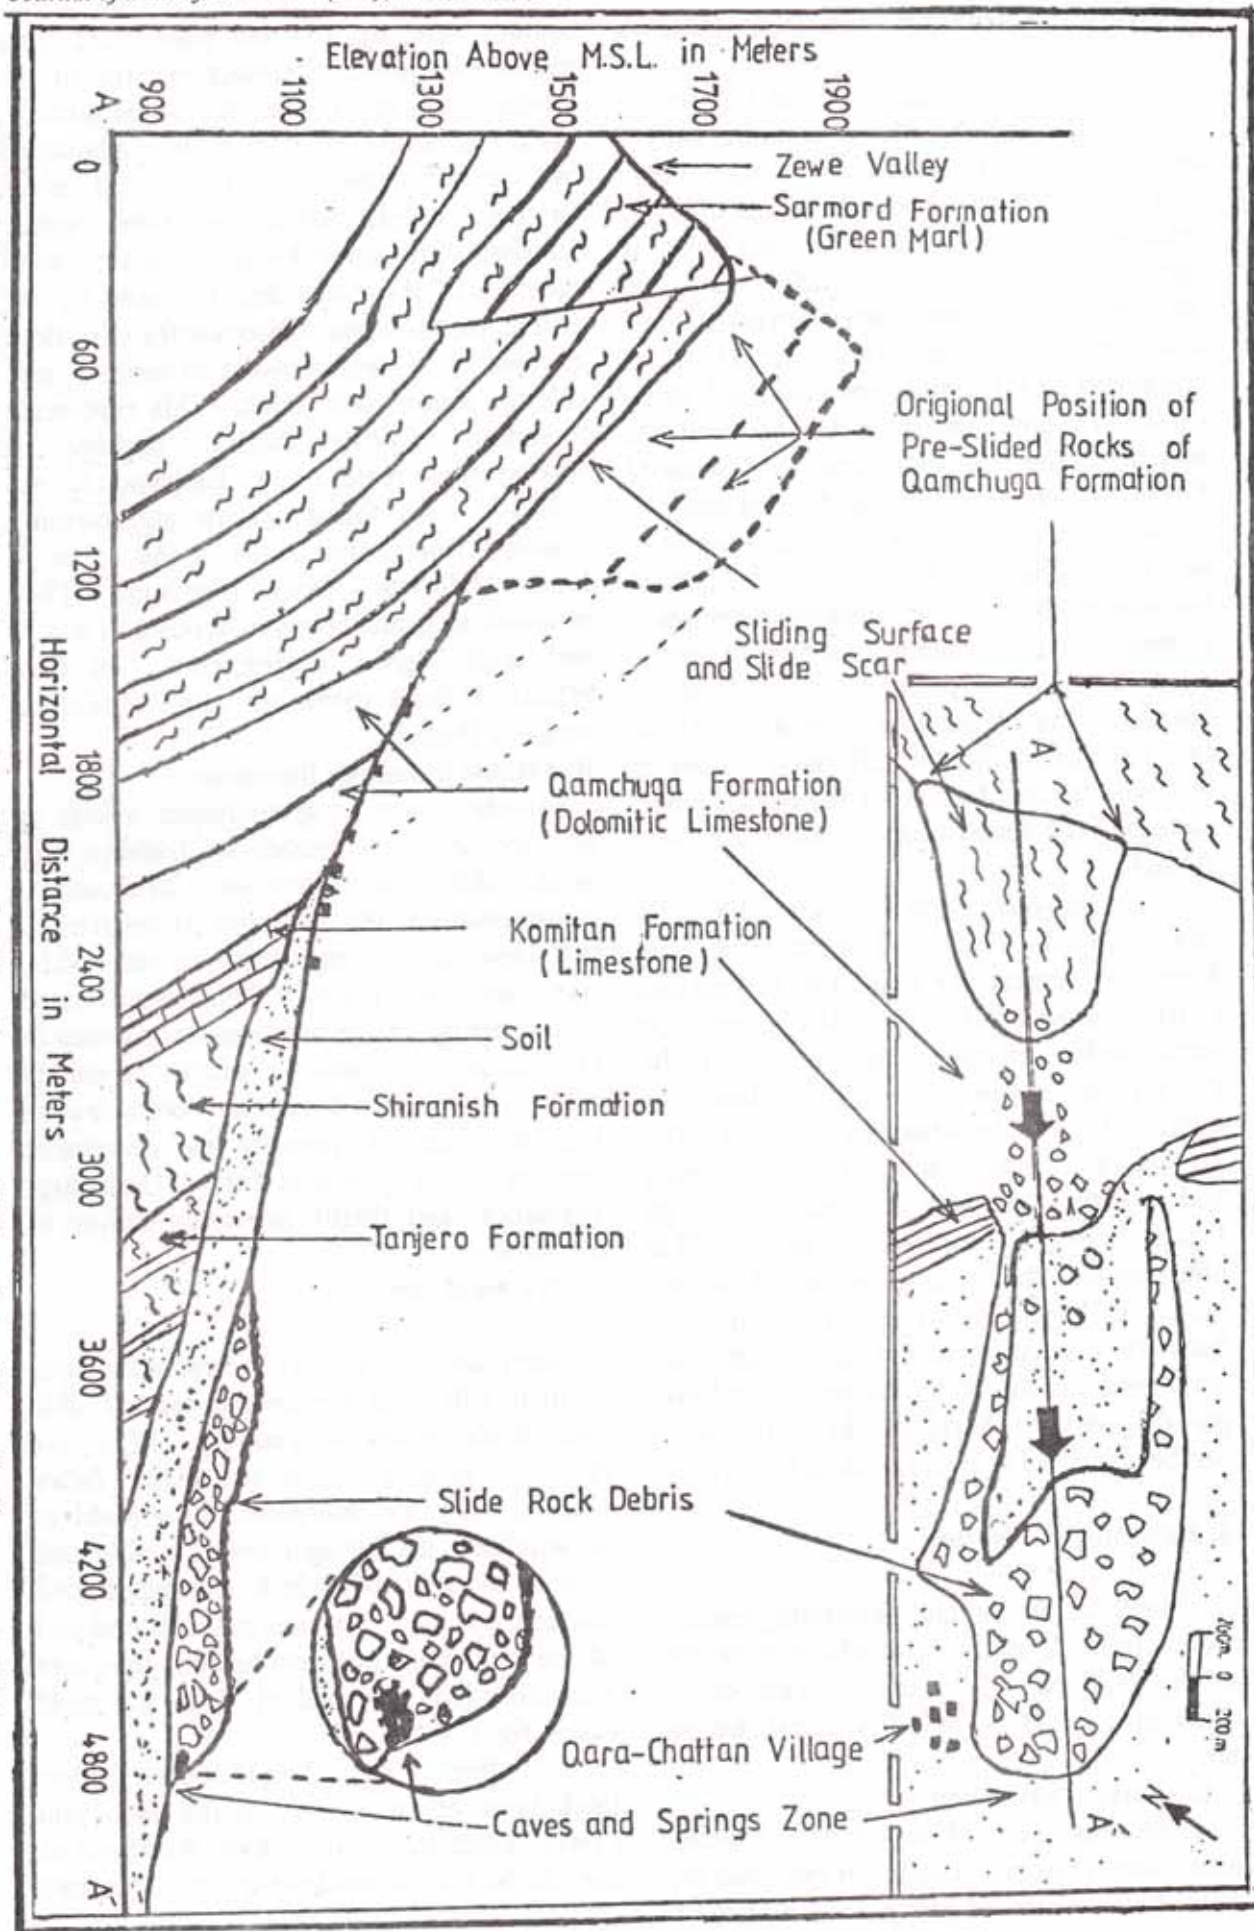
Fig.(3) Geological cross-section of southwestern limb of Pira-Magroon anticline along Qara-Chattan rockslide.

The main geomorphological factors are the slope height and slope angle of the failure before sliding. What concerned the former is the height of the slope which is more than (1900) meters above the surrounding plain on which the slided rock debris now rested, fig. (3). The amount of the slope angle is about 50 degrees. The relation between these two factors is reversible with slope stability (Bell, 1980)(5) and (Hoek and Bray, 1981) (6). This means that whenever the slope angle exceeds (45) degrees, the slope height is high and the slope is unstable. Moreover, these two factors are of prime important in increasing shearing stress, which caused failure, and sliding of the rocky materials down the slope to reach the present place, which is about 3.5 kms far from the original place. The slope angle and slope height of the area, before sliding, was determined from both sides (shoulders) of Qulla-Rash valley.

The second one(Sarmord Fn.) is composed of fissile soft green marl. This formation represents a good sliding surface (its upper part) in addition to good impermeable surface, which permit the ground water only to circulate in overlying Qamchuqa Formation. The groundwater increases internal weathering and pore pressure (Blyth and de Freitas,1974)(7). According to the field observations the sliding occurred on two types of surfaces, on the green marl of Sarmord Formation at the upper part of the slope and on the soil surface at its lower part,fig.(2&3). Therefore the initial sliding can be classified as plane sliding, fig. (4).

Many large caves are observed near Qara-Chattan village in the frontal part of slide rock debris, plate (4.2) and fig.(2).They are directly related to hydrological factor because they are interpreted as a mold of accumulated ice, brought down by slide rock debris. A part of which entrapped and covered by rock materials in the frontal part of the rock debris and then forming the caves after thawing. We called them ice mold caves, fig. (3).

The attitude of the joints and the beds which exist in the area are graphically represented on the stereonet to show their relations with that of the slope. The slope is inclined (50) degrees in the direction of (240) and the average dip of strata is (41) degrees in the direction of (228), fig. (4). The slope is parallel type depending on the divergence angle between slopes trend and the strata strikes. But according to a person whose face is toward the slope, it is left emergent slope type because the strike of the bedding appear to the left of the person. This type of slope also called concordant slope because the slope and strata are dipping in the same direction, fig.(3). The same principles were mentioned by (Al-Saadi, 1981(1) as a slope classification.

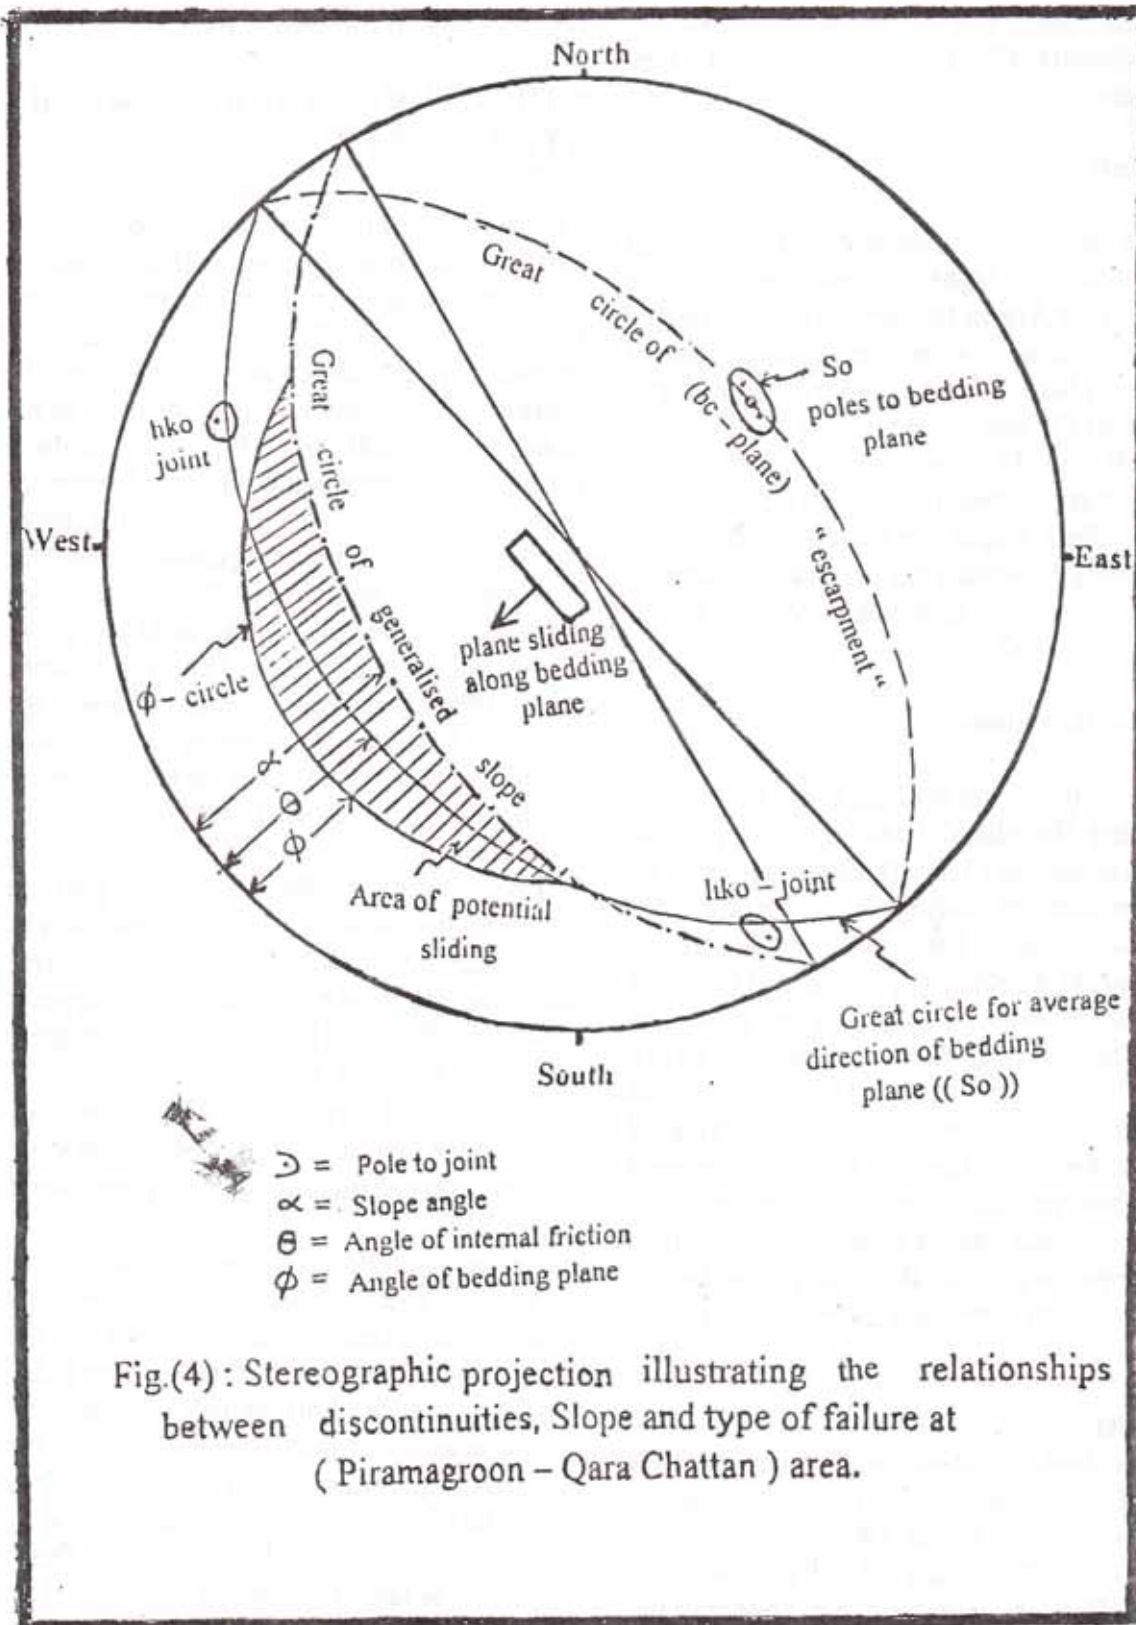
Fig.(4) : Stereographic projection illustrating the relationships between discontinuities, Slope and type of failure at (Piramagroon – Qara Chattan) area.

The sliding surface, as upper part of Sarmord Formation, is composed of soft green marl. This lithology has certain internal friction angle which is about (30) degrees (Hoek and Bray, 1981)(6). The stereographic projection revealed that:

- 1-The angle of strata ($\theta = 41$), is less than the slope toe angle (50) degree and more than internal friction angle of green marel ($\phi = 30$).
- 2-The great circle of strata is located in the area of potential sliding. As mentioned later the plane sliding occurred on the green marl in the same dip direction (228) of the strata. This happened when the cohesion became zero on the discontinuities surfaces. During the sliding, the bedding plane was represented as a sliding surface and conjugate (hko-system) as lateral release surface.

The dolomitic limestone of Qamchuqa Formation is highly jointed due to the intensity of Albian Orogeny. This is reflected by two master joints, extending tens of meters. These sets are hko type, dipping at angles of (70 and 80) degrees in the direction of (110 and 334) respectively, and fig. (4). They formed two major cliffs plate (3.3). These joints might be played a great role in the sliding by separation the masses laterally. They are of conjugate hko- system (Turner and Weiss, 1963)(9).

The dip of the bedding plane in the area, including the slided beds, is (41)degrees in the direction of (228) which coincides with the direction of sliding. The dip amount is less than the toe slope angle. This is returned to weathering processes at the slope toe, which cause daylighting of strata and consequently help failure (Hoek, 1971a)(10). According to (Hamasur, 1991)(11) serious rocksliding will occur when the strike of discontinuities is parallel to the slope trend and when the dip is in the direction of the slope provided that it's amount is less than the slope angle. In this study this fact is illustrated by stereonet representation, fig. (4).

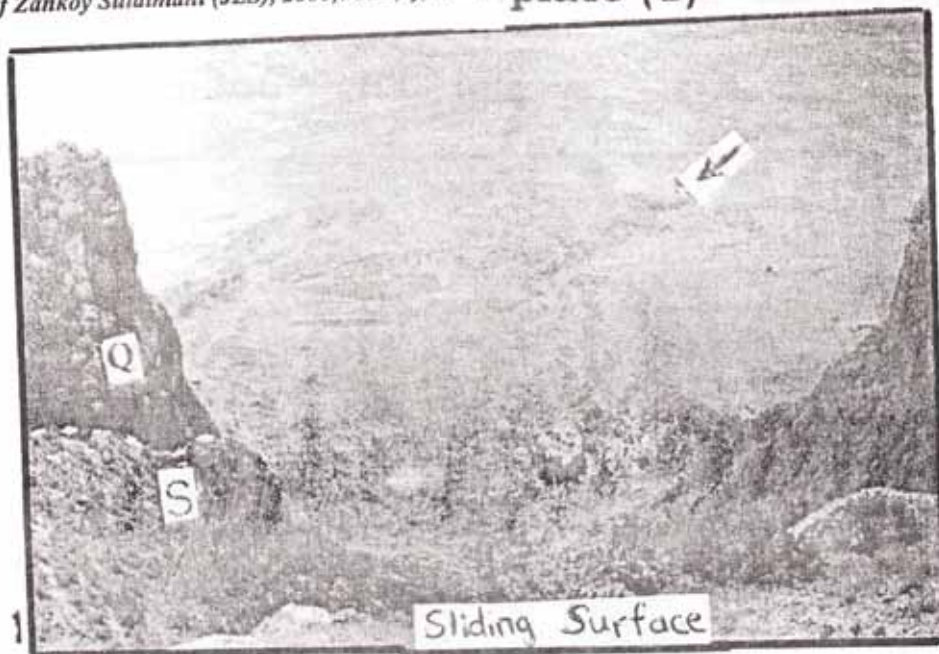
(2.1) lateral view of the Qara-Chattan rockslide as seen from the paved main road between Siulaimani and Dokan city. The arrow indicates where the ice mold cave exist in the frontal part of slide rock debris.

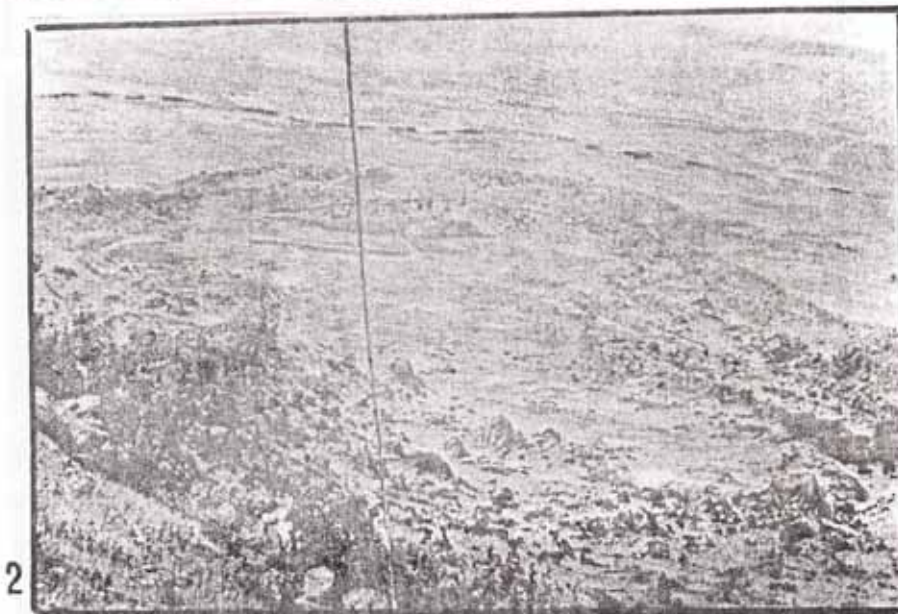
(2.2) Fissile green marl of Sarmord Formation as exposed in the valley which represents both, slide scar and sliding surface.

This represents the original place of slide rock debris and part of the surface on which the sliding occurred. It is parallel to bedding surface and located on the southwestern side of Pira-Magroon Mountain at an elevation of 2900 meters above sea level near the crest of the mountain. The field study is showed that the scar surface coincides with the upper boundary of the Sarmord Formation (Lower Cretaceous). This means that the sliding is occurred on this formation. It is composed of green marl and marly limestone plate (2.2)

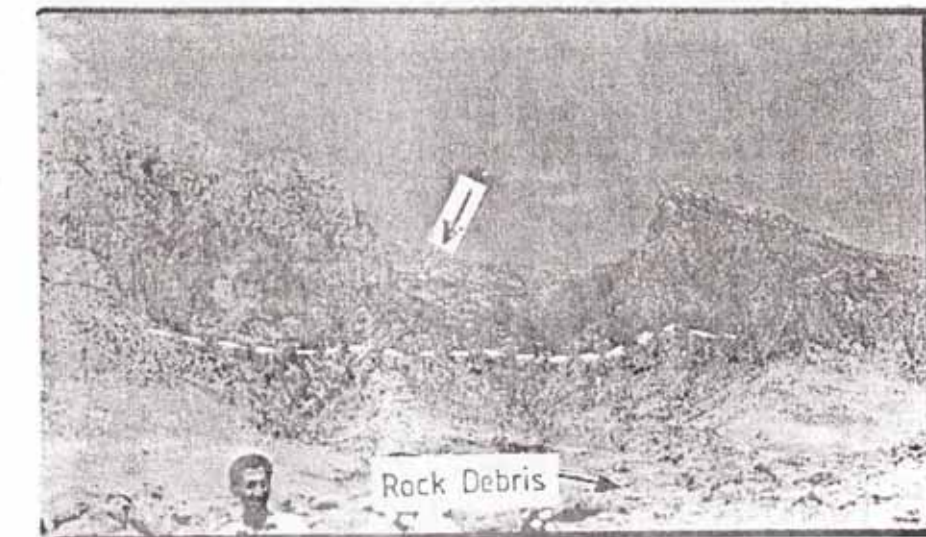
plate (2)

(2.3) The fault surface, dips (80) degree in the direction of s52w which locate near the mountain crest.(The showed surface is 1.5 m. wide)

One fault is found in the area which is located in the crest of Pira-Magroon mountain with dip of (80) degrees in the direction of 232, plate (2.3). This fault has direct effect in activating the sliding in the two ways. The first one is the rock masses detached easily from the main body of the mountain, and the second one is that the fault acted as natural avenue which permits

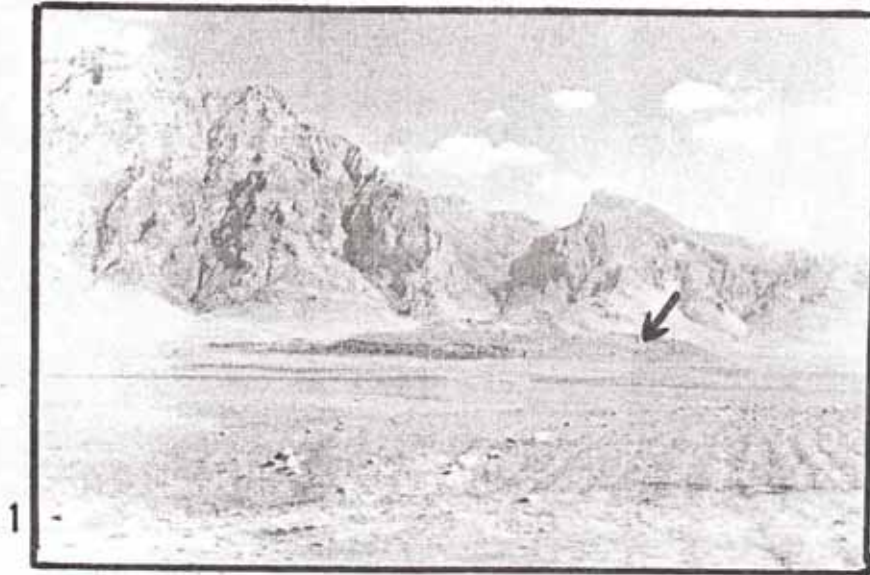
(3.1) The upper part of left side of Qulla-Rash valley, shows the contact (dashed line) between Sarmord Formation (S) and Qamchuqa Formation (Q) on the crest of the anticline, the white line shows the position of the fault.

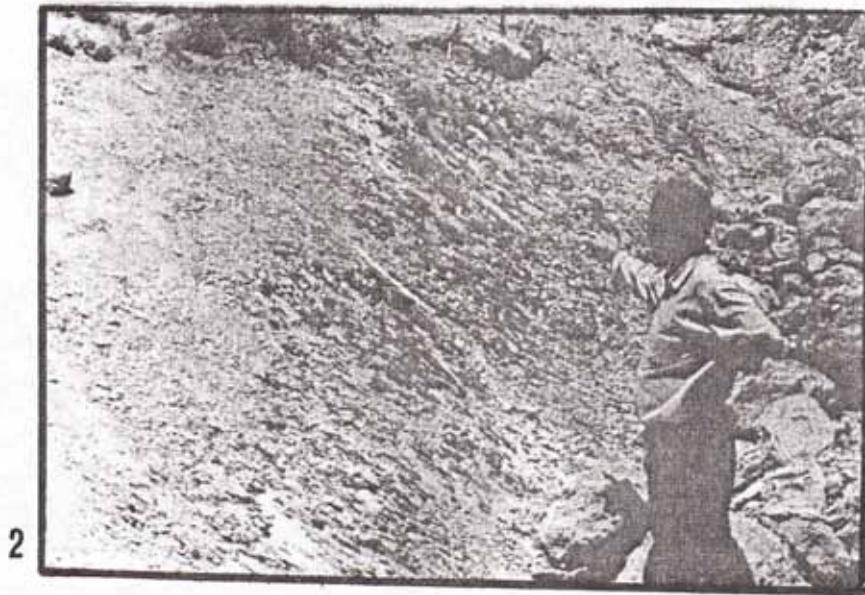
(3.2) The left part of the valley shows relatively smooth surface on which sliding occurred (sliding surface) as showed by an arrow. The letter (D) indicates location of daylighting strata.

and fig. (2& 3). The slide scar is relatively smooth and planar at its upper part while concave and covered by lagged rock blocks at the lower part, plate (3.2) and (3.3).

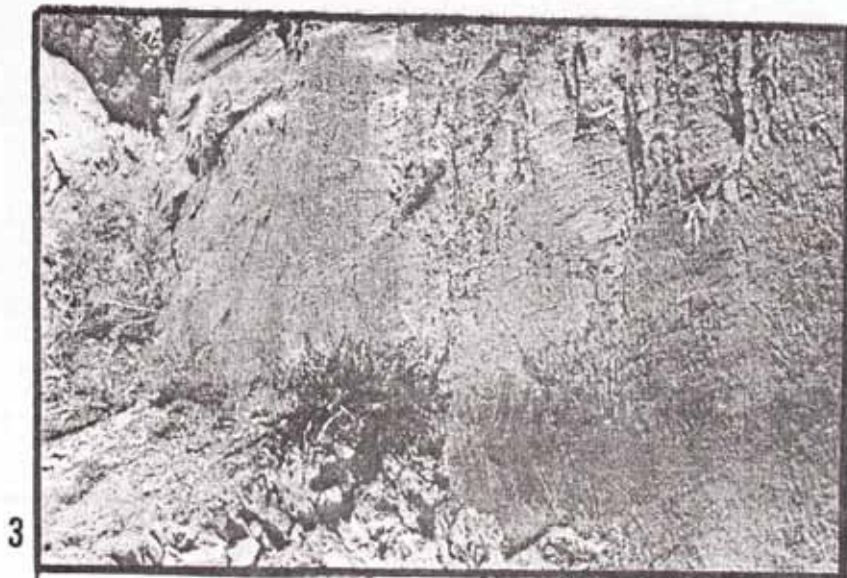
plate (3)

(3.3) Close photo of left shoulder (side of the valley) shows relatively fresh outcrop (slide scar) of both formation from which part of rock masses detached and slid in the direction shown by arrows. This photo is taken from the (S) position in the plate (3.1).

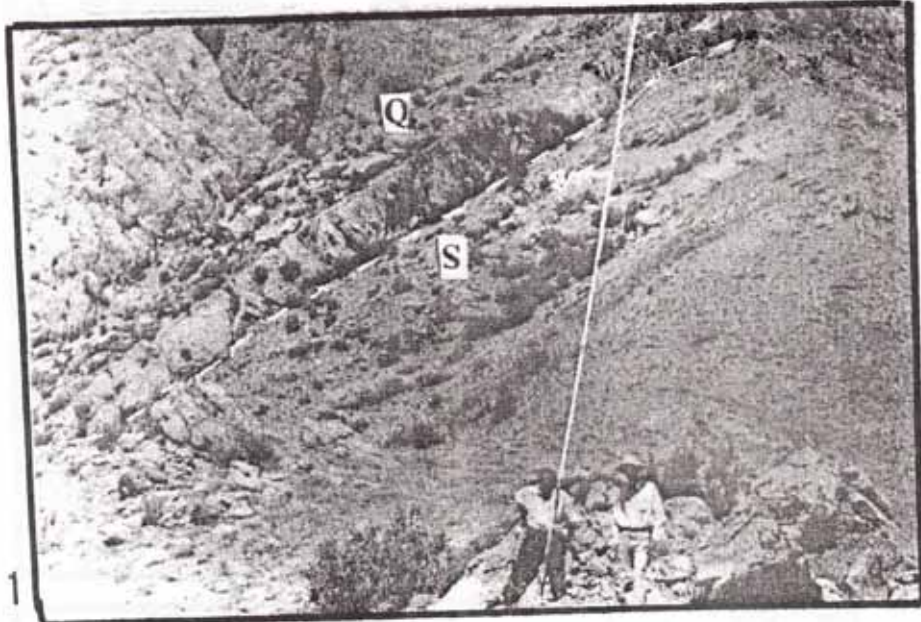
(1.1) general view of the Qara-Chattan rockslide as photographed from Pira-Magrron mountain crest. This photo shows Qulla-Rash valley and its U-shaped segment with the slide rock debris and sliding surface at the background. Q=Qamchuqa Formation, S=Sarmord Formation. The arrow indicates location of Qara-Chattan village and frontal part of slide rock debris.

A steep-sided valley is formed by Qara-Chattan rockslide. Its upper part is coincided with the slide scar and the lower one with upper part of sliding surface,, plate (1.1) and. (1.2). The valley locally called Qulla-Rash valley, which developed at expense of small former valley, existed in the same place. It is U-shaped, especially at its lower part. It formed by breaking former valley sides by the accelerated sliding rock masses when strikes them during down slope movement.

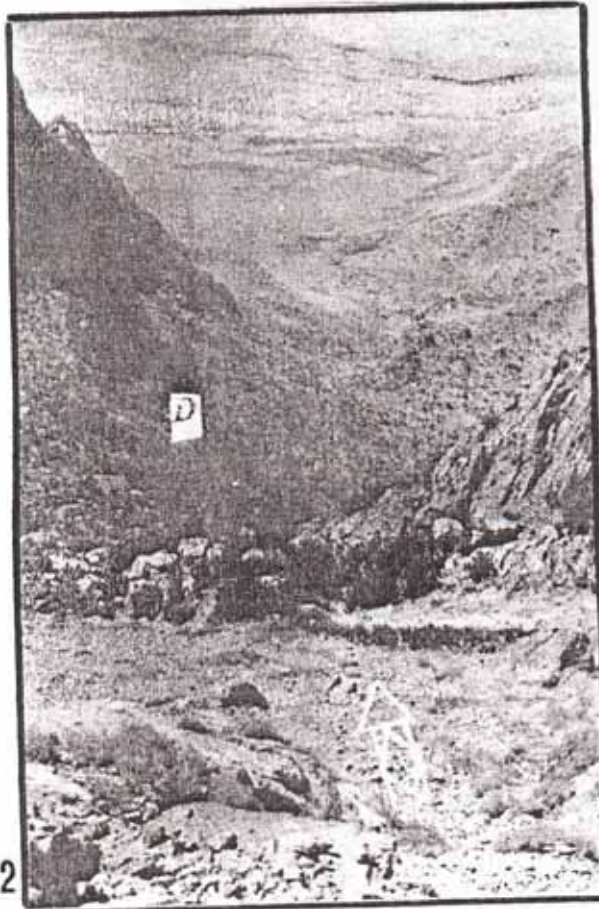
2

(1.2) close view of the lower part of sliding surface and rear part of sliding rock debris with some lagged blocks. The dashed lines

represent the paved road between Sulaimani and Dokan city.

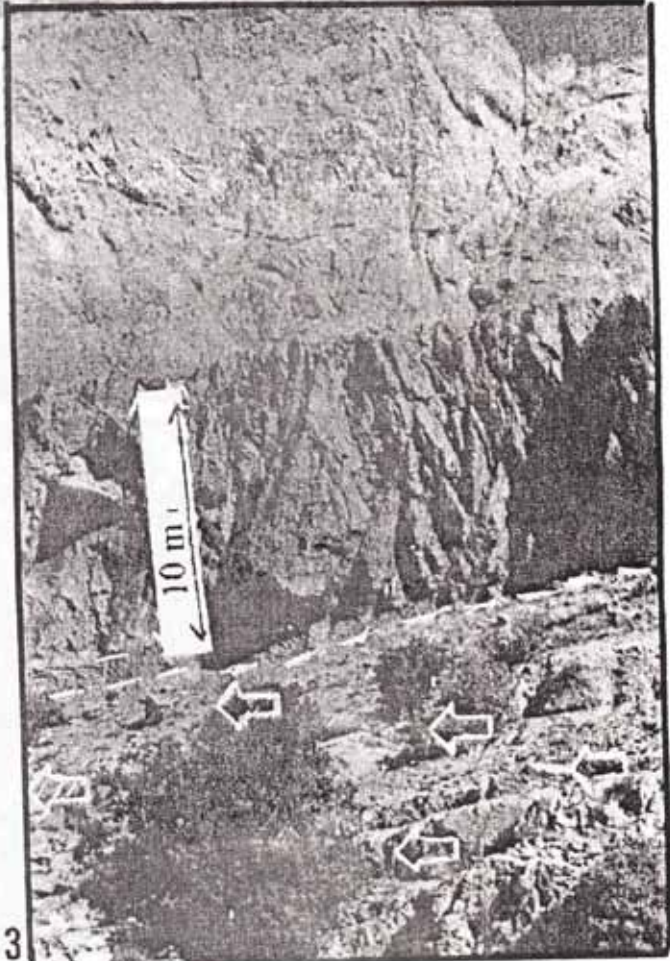
3

(1.3) Qulla-Rash valley as seen from the surface of slide rock debris. The dashed line indicate where solution caves and friable dolomitic limestone exist. The arrow indicates upper part of slide scar.

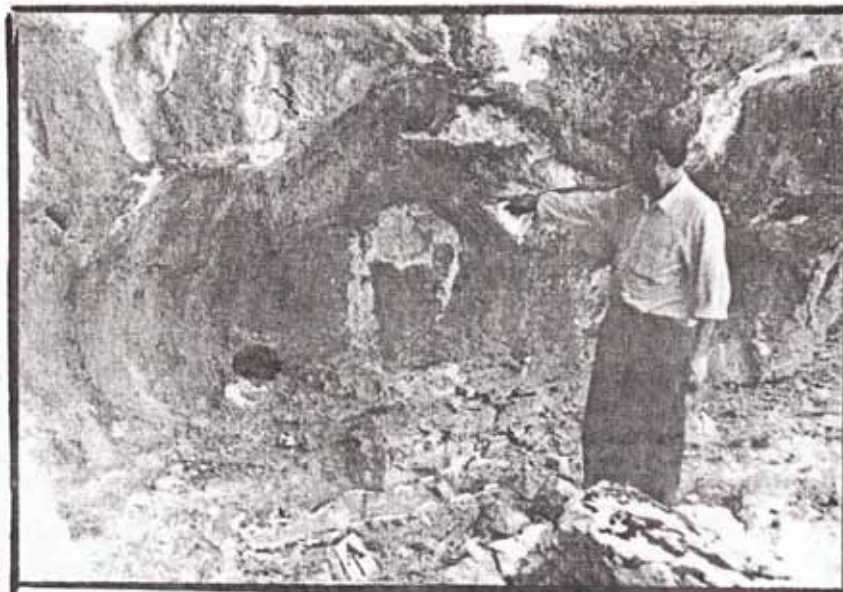
1

(4.1) solution caves with relatively smooth internal surface, the circular hole represents spring mouth before sliding. The arrow indicated (10) cm thick travertine layer at the floor of the cave.

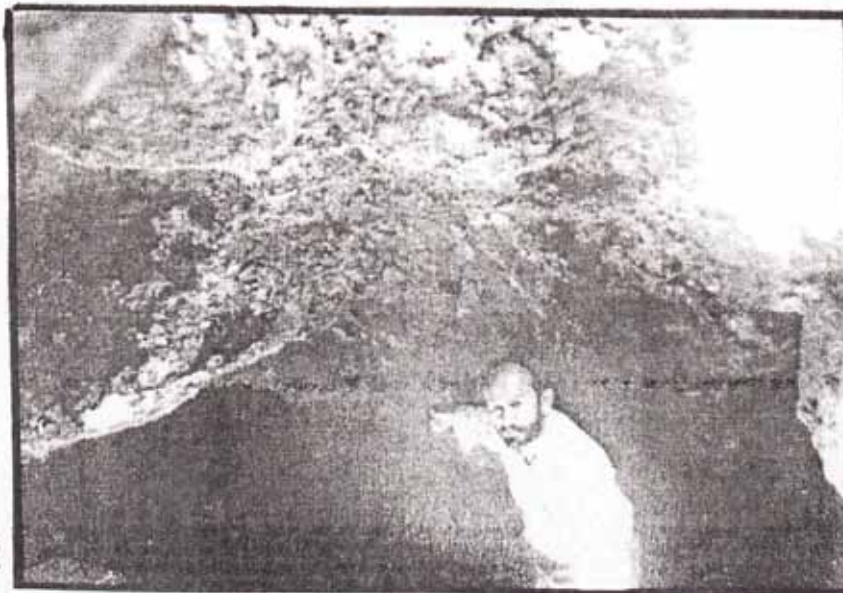
2

(4.2) Ice mold cave at the frontal part of slide rock debris.

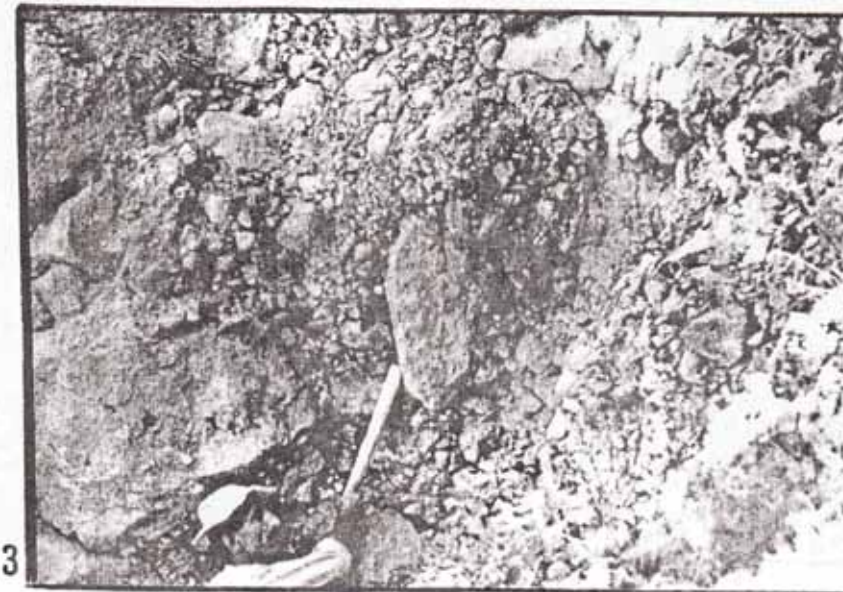
3

(4.3) The slide rock debris near the above cave which composed of boulder and pebble sized clasts.

The blocks and clasts are generally; matrix free and self- supported, except for some recent red soil filling the cavities between the blocks and clasts, plate (4.3). The slide masses occupy an area about two square kilometers, which has irregular, rough, rocky surface in contrast to planar and featureless surrounding area.
