## Rehabilitation of Reinforced Concrete Corner Beam-Column Joints Subjected to Damage

Zana Abdulla Aziz<sup>1</sup> & Mohamed Raouf Abdulkadir<sup>1</sup>

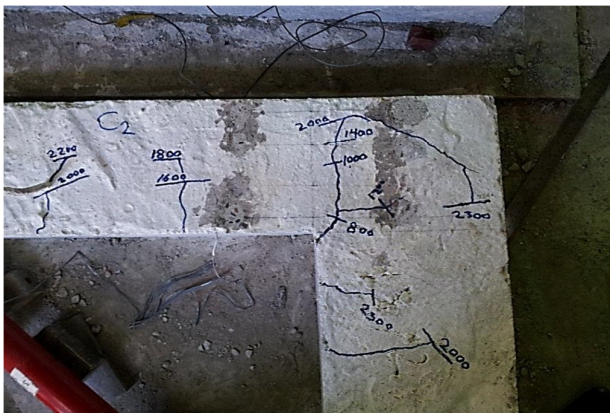
Fig.(3) Crack pattern of the control specimen (C2)

In the control specimens (C1 and C2) the first crack was formed at the inside face of the joint (beam-column intersection line) as expected at a load of 6kN opening the joint, inclined diagonally at 45 degrees to both the column and the beam due to the maximum bending tensile stress produced by the load opening the joint, as shown in Fig. (3). As the load increased to about 10kN, the crack split into two cracks, one paralleled to the beam and the other paralleled to the column, followed at load of 14-20kN by other cracks away from the joint mostly tensile flexure type of cracks due to maximum moments at faces of the column and the beam. At late stages (23-24kN), and close to the ultimate load, a diagonal crack (splitting) appeared approximately perpendicular to the line connecting the two inside and outside points of intersection of the joint and close to the outside joint point resulting from the high compressive stress induced at this region splitting that part of the joint away from the confinement reinforcement. This could be a tensile split inside the joint or a rupture of the portion of the concrete above and at the reinforcement bars under compression, in this case which is an opening column-beam connection. In the first case confinement steel bars (stirrups) would be most effective to control or minimize this type of failure. In the latter case also confinement bars in diagonal direction and good detailing would be effective and prevents cover rupture. Of course in other types of connections such as (T-joint) or (interior-joint) this type of failure would be most unlikely.

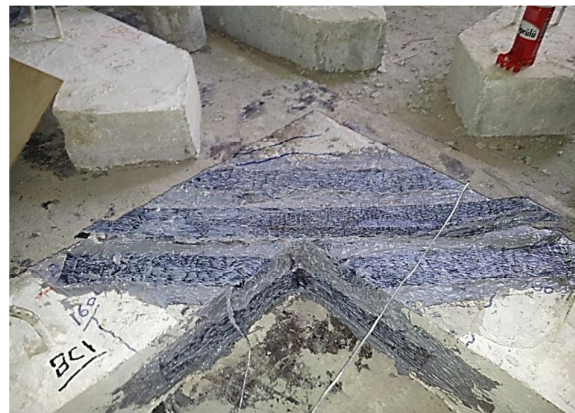
Fig.(4) Crack pattern of the specimen preloaded until 80% ultimate load and strengthened with strip of CFRP (BC1)

In the specimens strengthened with strips of CFRP (BC1 to BC4) after reloading, the first new crack formed at the tension face of the beam at a load of 18kN due to mostly tensile flexure stress, as shown in Fig.(4), outside the strengthened region. With increasing the load from 20 to 30kN other cracks occurred at tension face of the beam and the column away from the joint and went toward the top of the beam and column. At ultimate load 32-34kN the bond between CFRP strips and the concrete face failed and a diagonal crack (splitting) or cover rupture occurred similar to the control specimens. Compared to control specimens, for strengthened specimens, the first crack appeared outside the strengthening area (away from the joint) at a load of 18kN, whereas for control specimens the first crack occurred inside the joint (beam-column intersection line) at a load of 6kN, due to CFRP strip resistance against opening of the joint and increasing the tensile strength of the joint and causes stress increase at other locations and consequently cracks at these new locations. The ultimate load for control specimens were approximately 24kN while for strengthened specimens that preloaded up to first crack load and 80% of failure load were 33.7kN and 32.6kN, respectively, it means an increase of about 40.4% and 36% in load carrying capacity, respectively. The control specimens failed by diagonal cracks, G2 specimens failed in the same pattern after the bond failure between CFRP strips and concrete surface. The load carrying capacity after strengthening for specimens that damaged up to 80% ultimate load have smaller load carrying capacity than the specimens that damaged up to

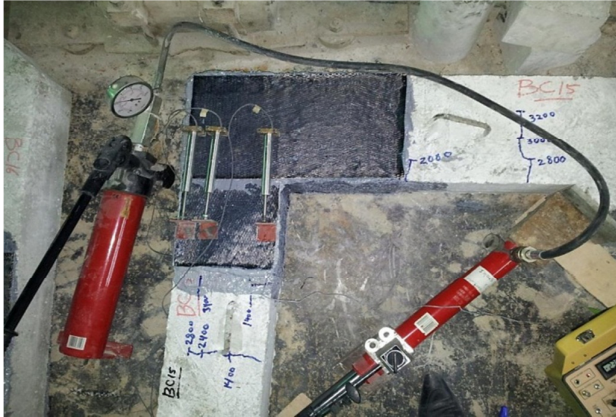
Fig.(7) Crack pattern of the specimen preloaded until first crack load and strengthened with full-CFRP (BC15)

failure occurred at the beam tension face at the edge of the CFRP sheet, and this caused delamination of concrete cover in some cases. Compared to the control specimens, the full coverage of the joint with CFRP resulted in shifting the cracks away from the joint and the strengthened region with an increase in load carrying capacity by 44.5% and 40.4% for strengthened specimens preloaded up to first crack load and 80% ultimate load, respectively, which is the largest ratio among the groups. It can be observed that load carrying capacity for the specimens subjected to preloading up to first crack is greater than those preloaded up to 80% ultimate loading before strengthening.

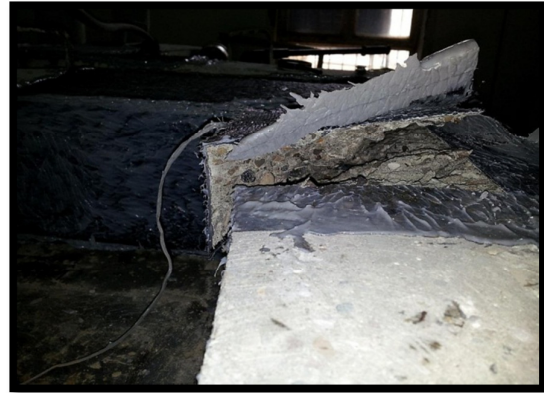
Fig.(8) Delamination of concrete cover for specimen preloaded until first crack load and strengthened with full-CFRP (BC16)

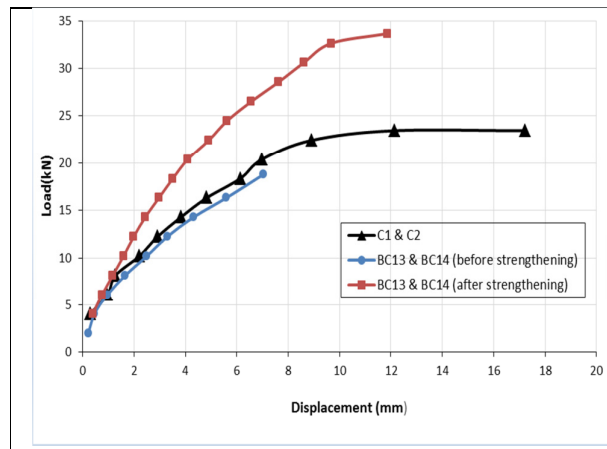
Fig.(10) Load-Displacement relationship for control specimens (C1 and C2) and strengthened specimens full-CFRP (preloaded up to 80% ultimate load)

Fig.(9) and Fig.(10) show the load-displacement curve for the control specimens and strengthened specimens before and after strengthening. All the load-displacement figures indicate a small increase in stiffness of strengthened specimens during the initial stages of loading. After cracking, and at any loading value, the displacements in the strengthened specimens are much less than the displacement in the non-strengthened specimens. However for the non-strengthened specimens (control tests and others preloaded) the displacements are almost similar or have little differences. This indicates that the strengthening process has made the joint more stiff and more ductile. The reduction in displacement is maximum for the specimens strengthened with full CFRP strips, and the least in the case of ferrocement strengthening.
